# Access Compliance Report

## Public Rights-of-Way

### (Curb Ramps)

| Intersection ID: 53252 | Main Street: MARLOWE_AV | Cross Street: FLEETWOOD_DR | Location: NW |

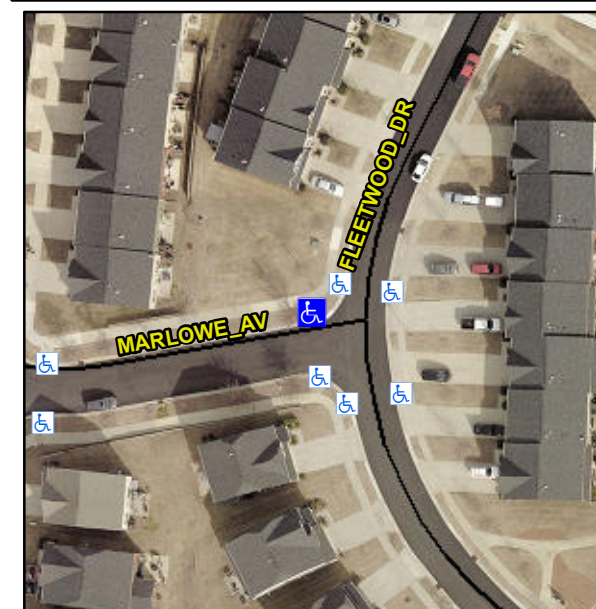
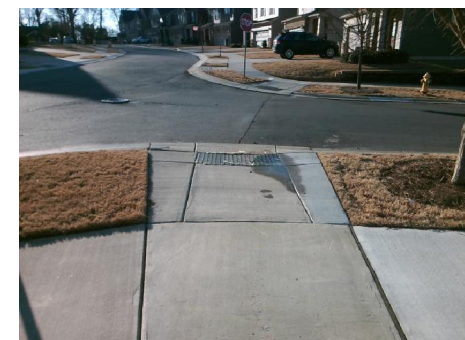
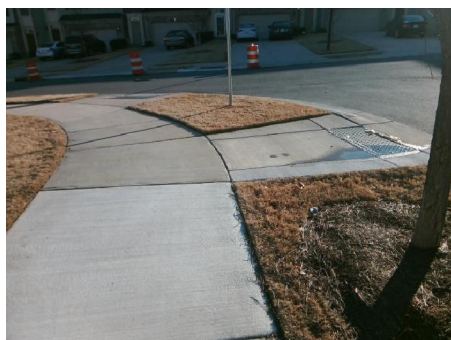
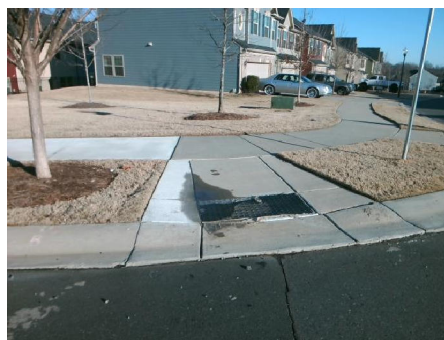
| ADA ID: AA12B80625BB | Ramp Type: BlendTrans1 | Initial Pass/Fail: Fail | Overall Compliance: No |
| Codes/Mitigation Info/Possible Solution | | | Severity Score: 10 |

**R304.5.1, R304.5.3**

| Compliance | Description | Data | Compliance | Description | Data |
|---|---|---|---|---|---|
| N/A | Ramp Length (in) | 95.5 | Yes | BlendTrans Slope (%) | 2.0 |
| No | Ramp Width (in) | 45.5 | No | BlendTrans XSlope (%) | 4.8 |

**Remove & Replace Curb Ramp With Two New Directional Ramps or Equivalent.**

Total Cost: \$ 3200.00
