Access Compliance Report

Public Rights-of-Way

(Curb Ramps)

Intersection ID: 12052	Main Street: E_17TH_ST	Cross Street: PEGRAM_ST	Location: S
ADA ID: AA14C75E6A25	Ramp Type: PerpDiag	Initial Pass/Fail: Fail	Overall Compliance: No
		Severity Score: 10

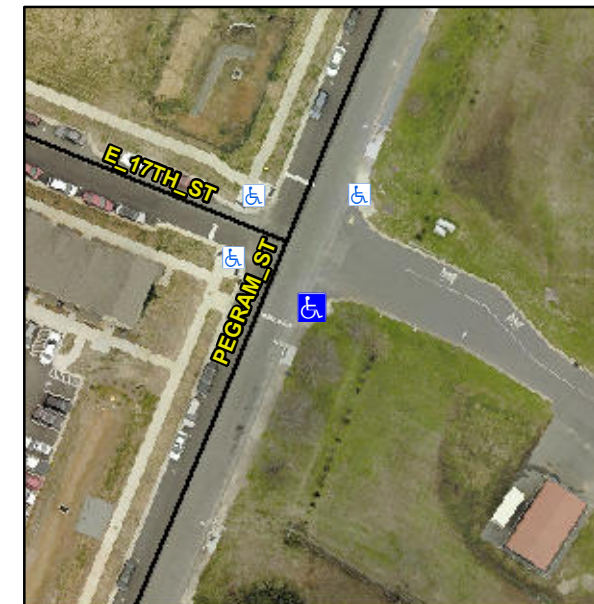
R304.5.1, R304.5.3

Compliance	Description	Data	Compliance	Description	Data
N/A	Ramp Length (in)	72.0	Yes	Ramp Slope (%)	5.3
No	Ramp Width (in)	47.0	No	Ramp XSlope (%)	3.4
N/A	Flare Type LT	N/A	N/A	Flare Type RT	N/A
N/A	Flare Slope LT (%)	N/A	N/A	Flare Slope RT (%)	N/A
N/A	Flare Traversable LT?	N/A	N/A	Flare Traversable RT?	N/A
N/A	Landing Length (in)	N/A	N/A	DWS Provided?	N/A
N/A	Landing Width (in)	N/A	N/A	DWS Contrast?	N/A
N/A	Landing Slope (%)	N/A	N/A	DWS Length (in)	N/A
N/A	Landing X Slope (%)	N/A	N/A	DWS Full Width?	N/A
N/A	Landing Curb? (Y/N)	N/A	N/A	DWS Offset (in)	N/A
N/A	Shared Landing?	N/A			
N/A	Gutter Ponding?	N/A	N/A	Gutter Slope (%)	N/A
N/A	Gutter Lip Ht (in)	N/A	N/A	Gutter X Slope (%)	N/A
N/A	Painted X Walk1?	No	N/A	Painted X Walk2?	No
	X Walk 1 Direction	To NE		X Walk 2 Direction	To NW
N/A	X Walk 1 Width (in)	N/A	N/A	X Walk 2 Width (in)	N/A
	X Walk 1 Slope (%)	6.6		X Walk 2 Slope (%)	4.7
	X Walk 1 X Slope (%)	2.4		X Walk 2 X Slope (%)	2.1

N/A	Ramp inside XWalk1?	N/A	N/A	Ramp inside XWalk2?	N/A
	Road Slope (%)	1.5	N/A	Clear Space?	N/A
	Road X Slope (%)	6.1	N/A	Clear Space to XWalk (in)	N/A
N/A	Any Obstructions?	N/A	N/A	Storm Grate/Utility Hazard?	N/A
	Obstruction Type			Storm Grate/Utility Type	
		N/A			N/A
			Yes	Surface Condition? (G/P)	Good

Remove & Replace Curb Ramp With Two New Directional Ramps or Equivalent.
