Access Compliance Report

Public Rights-of-Way

(Curb Ramps)

Intersection ID: 52768	Main Street: SHOPTON_RD	Cross Street: NEW_FASHION_WY	Location: SW
ADA ID: AA169247095B	Ramp Type: Perp	Initial Pass/Fail: Fail	Overall Compliance: No
Severity Score: 21.25			
Codes/Mitigation Info/Possible Solution		Field Measurements/Component Compliance

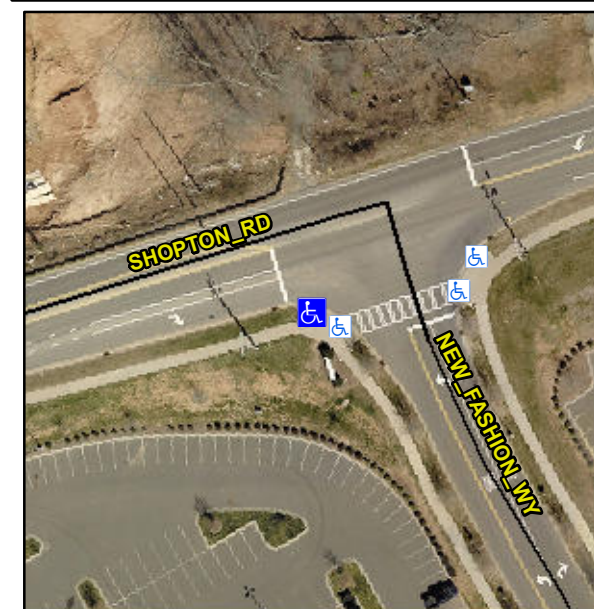
Not Found, R304.5.1, R304.5.3

Compliance	Description	Data	Compliance	Description	Data
N/A	Ramp Length (in)	96.0	Yes	Ramp Slope (%)	5.7
No	Ramp Width (in)	47.0	No	Ramp XSlope (%)	5.5
N/A	Flare Type LT	N/A	N/A	Flare Type RT	N/A
N/A	Flare Slope LT (%)	N/A	N/A	Flare Slope RT (%)	N/A
N/A	Flare Traversable LT?	N/A	N/A	Flare Traversable RT?	N/A
N/A	Landing Length (in)	N/A	N/A	DWS Provided?	N/A
N/A	Landing Width (in)	N/A	N/A	DWS Contrast?	N/A
N/A	Landing Slope (%)	N/A	N/A	DWS Length (in)	N/A
N/A	Landing X Slope (%)	N/A	N/A	DWS Full Width?	N/A
N/A	Landing Curb? (Y/N)	N/A	N/A	DWS Offset (in)	N/A
N/A	Shared Landing?	N/A			
N/A	Gutter Ponding?	N/A	N/A	Gutter Slope (%)	N/A
N/A	Gutter Lip Ht (in)	N/A	N/A	Gutter X Slope (%)	N/A
N/A	Painted X Walk1?	No	N/A	Painted X Walk2?	N/A
	X Walk 1 Direction	To N		X Walk 2 Direction	N/A
N/A	X Walk 1 Width (in)	N/A	N/A	X Walk 2 Width (in)	N/A
	X Walk 1 Slope (%)	8.7		X Walk 2 Slope (%)	N/A
	X Walk 1 X Slope (%)	1.8		X Walk 2 X Slope (%)	N/A

N/A	Ramp inside XWalk1?	N/A	N/A	Ramp inside XWalk2?	N/A
	Road Slope (%)	N/A	N/A	Clear Space?	N/A
	Road X Slope (%)	N/A	N/A	Clear Space to XWalk (in)	N/A
N/A	Any Obstructions?	N/A	N/A	Storm Grate/Utility Hazard?	N/A
	Obstruction Type			Storm Grate/Utility Type	
		N/A			N/A
			Yes	Surface Condition? (G/P)	Good

Possible Solutions:

Remove & Replace Entire Ramp.

Total Cost: \$ 1850.00
