Access Compliance Report

Public Rights-of-Way

(Curb Ramps)

Intersection ID: 50320	Main Street: BRYN_ATHYN_CT	Cross Street: CINDY_LN	Location: SW
ADA ID: AA2B6E7AC953	Ramp Type: Directional1	Initial Pass/Fail: Pass	Overall Compliance: No
Severity Score: 2.5			
Codes/Mitigation Info/Possible Solution		Field Measurements/Component Compliance

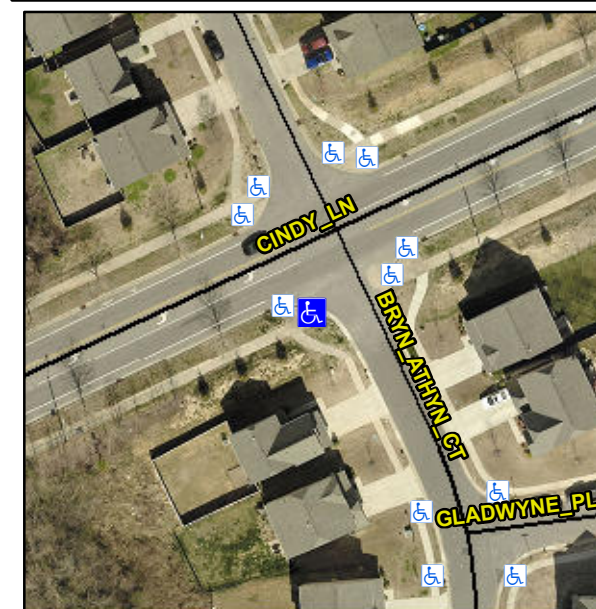
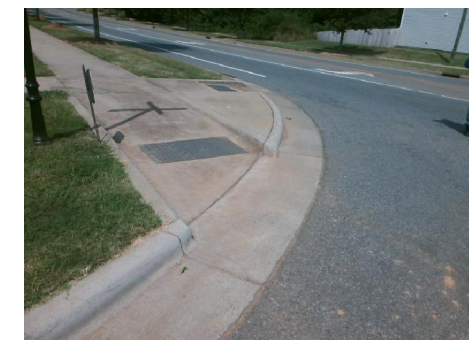
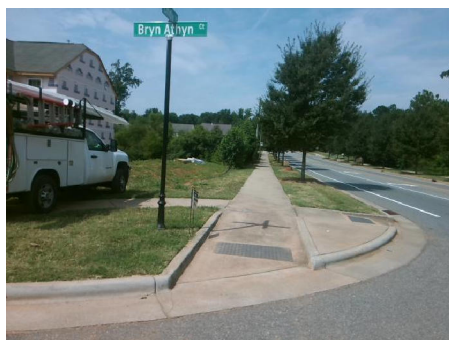
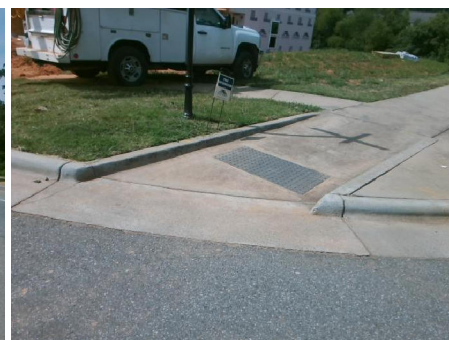
Compliance	Description	Data	Compliance	Description	Data
N/A	Ramp Length (in)	134.0	Yes	Grade Break?	Yes
Yes	Ramp Width (in)	66.5	Yes	Grade Break Slope (%)	2.8
Yes	Ramp Slope (%)	5.1	Yes	Grade Break XSlope (%)	1.7
Yes	Ramp XSlope (%)	1.1			
Yes	Flare Type LT	N/A	Yes	Flare Type RT	N/A
N/A	Flare Slope LT (%)	N/A	N/A	Flare Slope RT (%)	N/A
N/A	Flare Traversable LT?	No	N/A	Flare Traversable RT?	No
Yes	Landing Length (in)	72.0	Yes	DWS Provided?	Yes
Yes	Landing Width (in)	70.0	Yes	DWS Contrast?	Yes
No	Landing Slope (%)	2.2	Yes	DWS Length (in)	24.0
Yes	Landing X Slope (%)	1.3	No	DWS Full Width?	No
N/A	Landing Curb? (Y/N)	N/A	Yes	DWS Offset LT (in)	42.5
N/A	Shared Landing?	Yes	No	DWS Offset RT (in)	8.0
Yes	Gutter Ponding?	No	Yes	Gutter Slope (%)	1.8
Yes	Gutter Lip Ht (in)	0.0	Yes	Gutter X Slope (%)	1.0
N/A	Painted X Walk1?	No		Road Slope (%)	3.5
	X Walk 1 Direction	To E		Road X Slope (%)	1.2
	X Walk 1 Width (in)	N/A		Clear Space?	Yes

X Walk 1 Slope (%)	3.5	N/A	Clear Space to XWalk (in)	N/A
	X Walk 1 X Slope (%)	1.2	Yes	Storm Grate/Utility Hazard?	No
N/A	Ramp inside XWalk1?	N/A		Storm Grate/Utility Type	
Yes	Any Obstructions?	No			N/A
	Obstruction Type		Yes	Surface Condition? (G/P)	Good
			N/A	Curb Slope (%)	5.7

Possible Solutions:

Remove & Replace Entire Ramp.
