# Access Compliance Report

## Public Rights-of-Way

### (Curb Ramps)

| Intersection ID: 10353 | Main Street: E_35TH_ST | Cross Street: N_MCDOWELL_ST | Location: S |

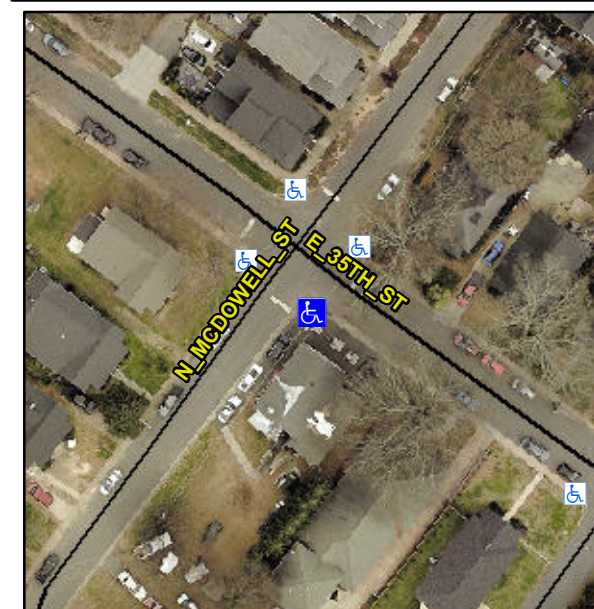
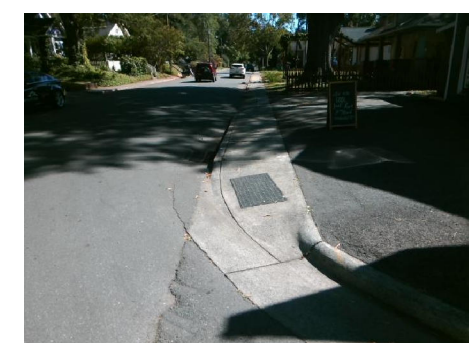
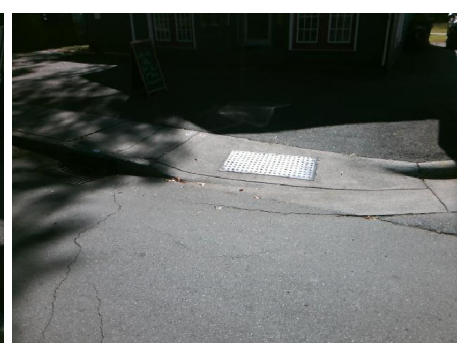
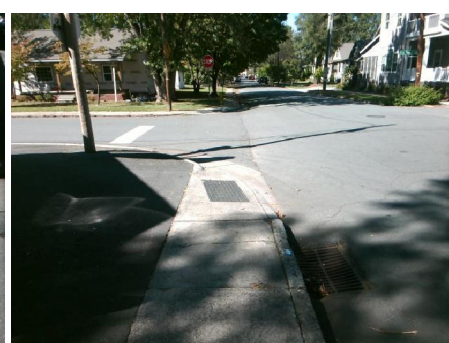
| ADA ID: AA34E221AB4F | Ramp Type: Perp | Initial Pass/Fail: Fail | Overall Compliance: No |

**Not Found, R304.2.2**

| Compliance | Description | Data | Compliance | Description | Data |
|---|---|---|---|---|---|
| N/A | Ramp Length (in) | 38.0 | No | Ramp Slope (%) | 8.9 |

Possible Solutions:

**Remove & Replace Entire Ramp.**
