Access Compliance Report

Public Rights-of-Way

(Curb Ramps)

Intersection ID: N/A	Main Street: CRESSWIND BV	Cross Street: SHOFF CIR	Location: S
ADA ID: AA46E6849007	Ramp Type: Perp	Initial Pass/Fail: Fail	Overall Compliance: No
		Severity Score: 25

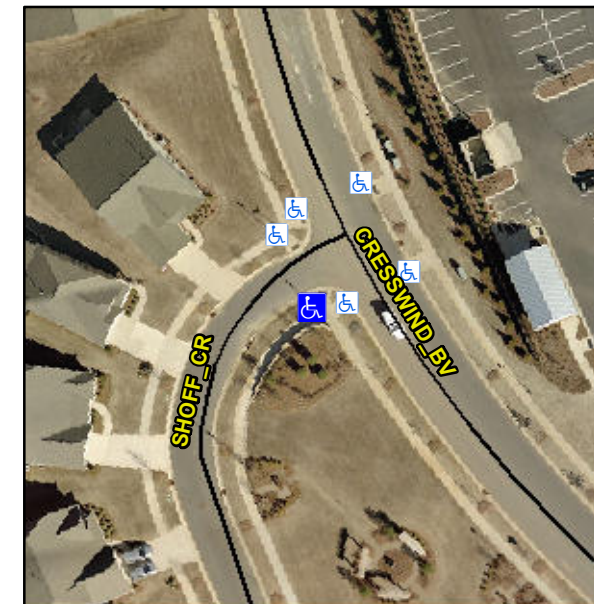
Not Found, R304.5.3

Compliance	Description	Data	Compliance	Description	Data
N/A	Ramp Length (in)	96.0	Yes	Ramp Slope (%)	7.2
Yes	Ramp Width (in)	60.0	No	Ramp XSlope (%)	7.8
N/A	Flare Type LT	N/A	N/A	Flare Type RT	N/A
N/A	Flare Slope LT (%)	N/A	N/A	Flare Slope RT (%)	N/A
N/A	Flare Traversable LT?	No	N/A	Flare Traversable RT?	No
N/A	Landing Length (in)	N/A	N/A	DWS Provided?	N/A
N/A	Landing Width (in)	N/A	N/A	DWS Contrast?	N/A
N/A	Landing Slope (%)	N/A	N/A	DWS Length (in)	N/A
N/A	Landing X Slope (%)	N/A	N/A	DWS Full Width?	N/A
N/A	Landing Curb? (Y/N)	N/A	N/A	DWS Offset (in)	N/A
N/A	Shared Landing?	N/A			
N/A	Gutter Ponding?	N/A	N/A	Gutter Slope (%)	N/A
N/A	Gutter Lip Ht (in)	N/A	N/A	Gutter X Slope (%)	N/A
N/A	Painted X Walk1?	No	N/A	Painted X Walk2?	N/A
	X Walk 1 Direction	To N		X Walk 2 Direction	N/A
N/A	X Walk 1 Width (in)	N/A	N/A	X Walk 2 Width (in)	N/A
	X Walk 1 Slope (%)	0.7		X Walk 2 Slope (%)	N/A
	X Walk 1 X Slope (%)	6.8		X Walk 2 X Slope (%)	N/A

Remove & Replace Entire Ramp.

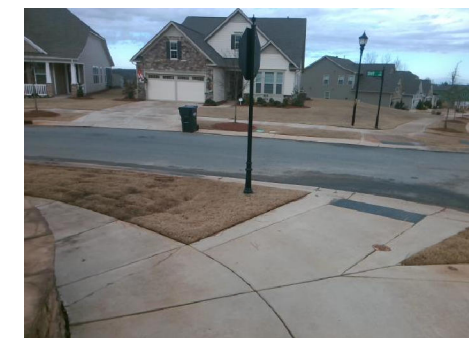
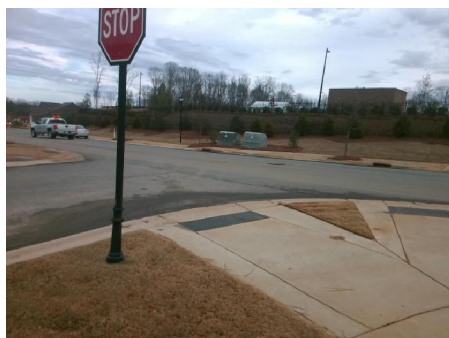
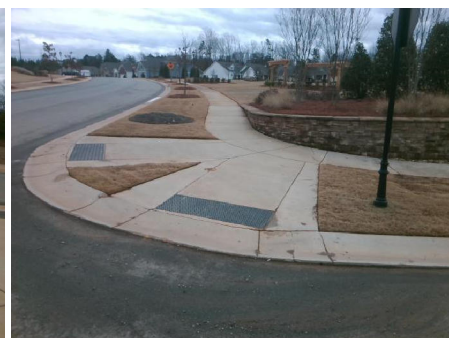
N/A	Ramp inside XWalk1?	N/A	N/A	Ramp inside XWalk2?	N/A
	Road Slope (%)	N/A	N/A	Clear Space?	N/A
	Road X Slope (%)	N/A	N/A	Clear Space to XWalk (in)	N/A
N/A	Any Obstructions?	N/A	N/A	Storm Grate/Utility Hazard?	N/A
	Obstruction Type			Storm Grate/Utility Type	
		N/A			N/A
			Yes	Surface Condition? (G/P)	Good

Street 1 Name SHOFF CIR
 Stop Condition-Street 2 StopSign
 Street 2 Name N/A
 Stop Condition-Street 1 N/A
