Access Compliance Report

Public Rights-of-Way

(Curb Ramps)

Intersection ID: 48002	Main Street: THELEMA_LN	Cross Street: CLYMER_CT	Location:	SE
ADA ID: AA488A870991	Ramp Type: PerpDiag	Initial Pass/Fail: Fail	Overall Compliance: No	Severity Score: 35
Codes/Mitigation Info/Possible Solution		Field Measurements/Component Compliance

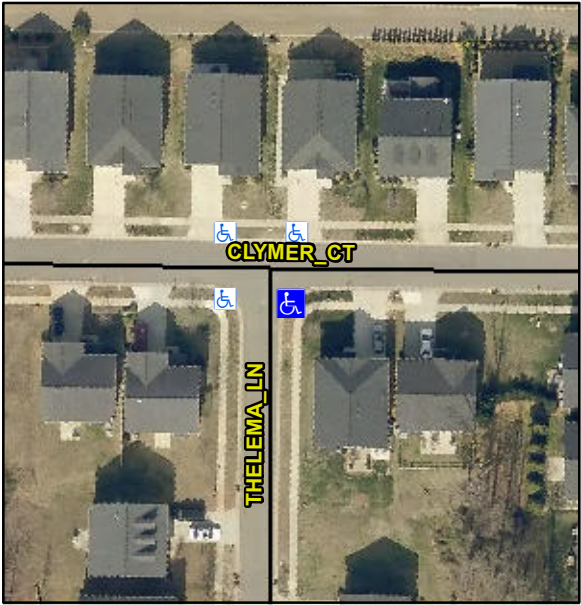
Possible Solutions:		Compliance	Description	Data	Compliance	Description	Data
	Remove & Replace Curb Ramp With Two New Directional Ramps or Equivalent.		N/A	Ramp Length (in)	70.5	No	Ramp Slope (%)	13.7

Surveyor Notes:		No	Ramp Width (in)	46.5	No	Ramp XSlope (%)	3.4
	N/A		N/A	Flare Type LT	N/A	N/A	Flare Type RT	N/A

PROW/ADA:		N/A	Flare Slope LT (%)	N/A	N/A	Flare Slope RT (%)	N/A
	Not Found, R304.5.1, R304.2.2, R304.5.3		N/A	Flare Traversable LT?	N/A	N/A	Flare Traversable RT?	N/A
