# Access Compliance Report

## Public Rights-of-Way

### (Curb Ramps)

| Intersection ID: 16086 | Main Street: HOLLIS_RD | Cross Street: WESTON_ST | Location: NE |

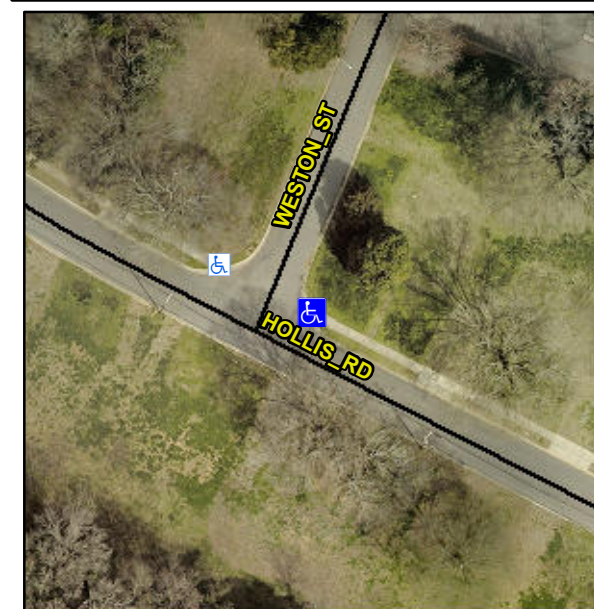
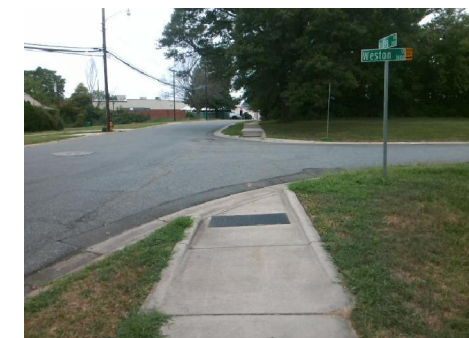
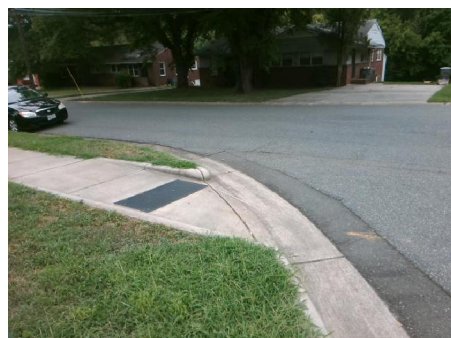
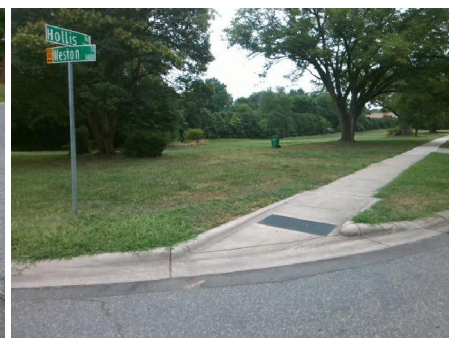
| ADA ID: AA4C59747319 | Ramp Type: Directional1 | Initial Pass/Fail: Fail | Overall Compliance: No |
| Severity Score: 12.5 | | | |

| Compliance | Description | Data | Compliance | Description | Data |
|---|---|---|---|---|---|
| No | Ramp XSlope (%) | 5.2 | | | |

**Remove & Replace Entire Ramp.**

**R304.5.3**

\$ 1600.00
