# Access Compliance Report

## Public Rights-of-Way

### (Curb Ramps)

| Intersection ID: 9823 | Main Street: CONCORDIA_AV | Cross Street: GRIMES_ST | Location: W |

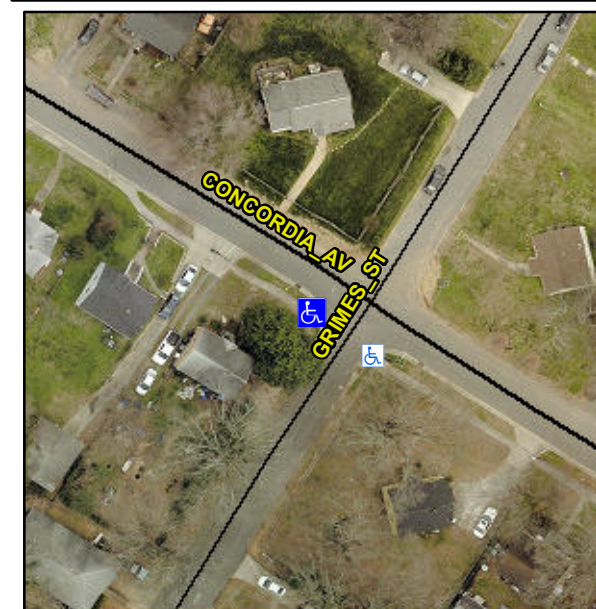
**R304.2.2-Perp, R304.3.2-Para,  
R304.5.3, R305.1.4, R305.2, R304.5.4**

| Compliance | Description | Data | Compliance | Description | Data |
|---|---|---|---|---|---|
| Yes | Ramp Width (in) | 57.0 | No | Grade Break Slope (%) | 6.7 |
| Yes | Ramp Slope (%) | 7.5 | No | Grade Break XSlope (%) | 2.2 |
| No | Landing Slope (%) | 4.2 | Yes | DWS Length (in) | 24.0 |
| Yes | Landing X Slope (%) | 2.0 | No | DWS Full Width? | No |
| N/A | Shared Landing? | No | No | DWS Offset RT (in) | 8.0 |
| Yes | Gutter Ponding? | No | No | Gutter Slope (%) | 5.1 |

**Remove & Replace Entire Ramp.  
Remove & Replace Gutter.**
