Access Compliance Report

Public Rights-of-Way

(Curb Ramps)

Intersection ID: 22317	Main Street: SHARON_RD	Cross Street: SHARON_ACRES_RD	Location: E
ADA ID: AA5928FCACA6	Ramp Type: Perp	Initial Pass/Fail: Fail	Overall Compliance: No
Severity Score: 46.25			
Codes/Mitigation Info/Possible Solution		Field Measurements/Component Compliance

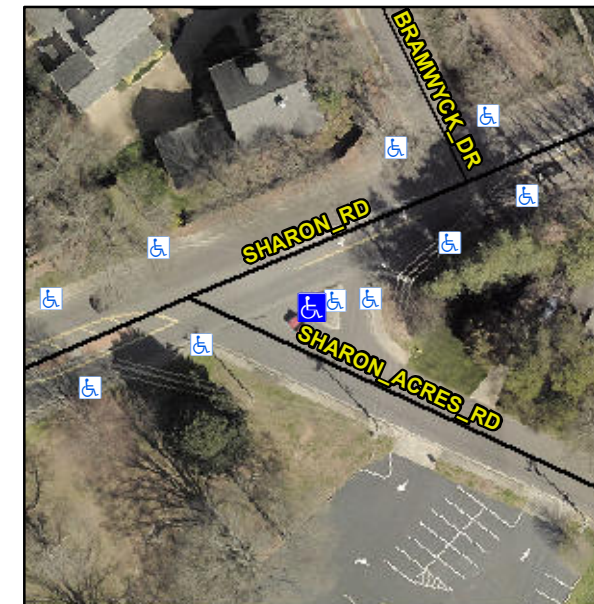
Not Found, R304.5.1, R304.2.2, R304.5.3

Compliance	Description	Data	Compliance	Description	Data
N/A	Ramp Length (in)	33.0	No	Ramp Slope (%)	10.2
No	Ramp Width (in)	40.0	No	Ramp XSlope (%)	8.2
N/A	Flare Type LT	N/A	N/A	Flare Type RT	N/A
N/A	Flare Slope LT (%)	N/A	N/A	Flare Slope RT (%)	N/A
N/A	Flare Traversable LT?	N/A	N/A	Flare Traversable RT?	N/A
N/A	Landing Length (in)	N/A	N/A	DWS Provided?	N/A
N/A	Landing Width (in)	N/A	N/A	DWS Contrast?	N/A
N/A	Landing Slope (%)	N/A	N/A	DWS Length (in)	N/A
N/A	Landing X Slope (%)	N/A	N/A	DWS Full Width?	N/A
N/A	Landing Curb? (Y/N)	N/A	N/A	DWS Offset (in)	N/A
N/A	Shared Landing?	N/A			
N/A	Gutter Ponding?	N/A	N/A	Gutter Slope (%)	N/A
N/A	Gutter Lip Ht (in)	N/A	N/A	Gutter X Slope (%)	N/A
N/A	Painted X Walk1?	No	N/A	Painted X Walk2?	N/A
	X Walk 1 Direction	To W		X Walk 2 Direction	N/A
N/A	X Walk 1 Width (in)	N/A	N/A	X Walk 2 Width (in)	N/A
	X Walk 1 Slope (%)	1.5		X Walk 2 Slope (%)	N/A
	X Walk 1 X Slope (%)	2.3		X Walk 2 X Slope (%)	N/A

N/A	Ramp inside XWalk1?	N/A	N/A	Ramp inside XWalk2?	N/A
	Road Slope (%)	N/A	N/A	Clear Space?	N/A
	Road X Slope (%)	N/A	N/A	Clear Space to XWalk (in)	N/A
N/A	Any Obstructions?	N/A	N/A	Storm Grate/Utility Hazard?	N/A
	Obstruction Type			Storm Grate/Utility Type	
		N/A			N/A
			Yes	Surface Condition? (G/P)	Good

Possible Solutions:

Remove & Replace Entire Ramp.

Total Cost: \$ 1850.00
