# Access Compliance Report

## Public Rights-of-Way

| Intersection ID: 5858 | Main Street: CARMENET_LN | Cross Street: LONG_PAW_LN | Location: SE |
| ADA ID: AA599F749DD2 | Ramp Type: PerpDiag | Initial Pass/Fail: Fail | Overall Compliance: No |

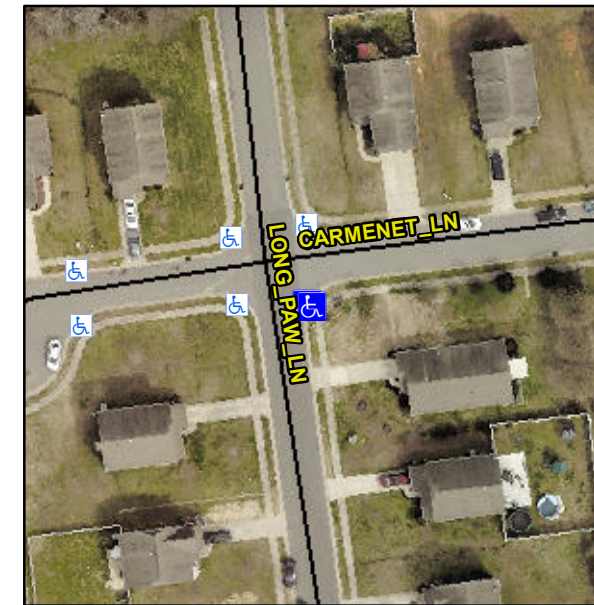
**Not Found, R304.5.1, R304.5.3**

| Compliance | Description | Data | Compliance | Description | Data |
|---|---|---|---|---|---|
| N/A | Ramp Length (in) | 48.5 | Yes | Ramp Slope (%) | 6.0 |
| No | Ramp Width (in) | 37.0 | No | Ramp XSlope (%) | 2.6 |

**Remove & Replace Curb Ramp With Two New Directional Ramps or Equivalent.**
