# Access Compliance Report

## Public Rights-of-Way

### (Curb Ramps)

Intersection ID: 14349	Main Street: REMOUNT_RD	Cross Street: TOOMEY_AV	Location: W
ADA ID: AA65E723CBF0	Ramp Type: Perp	Initial Pass/Fail: Fail	Overall Compliance: No
		Severity Score: 22.5	
Codes/Mitigation Info/Possible Solution		Field Measurements/Component Compliance

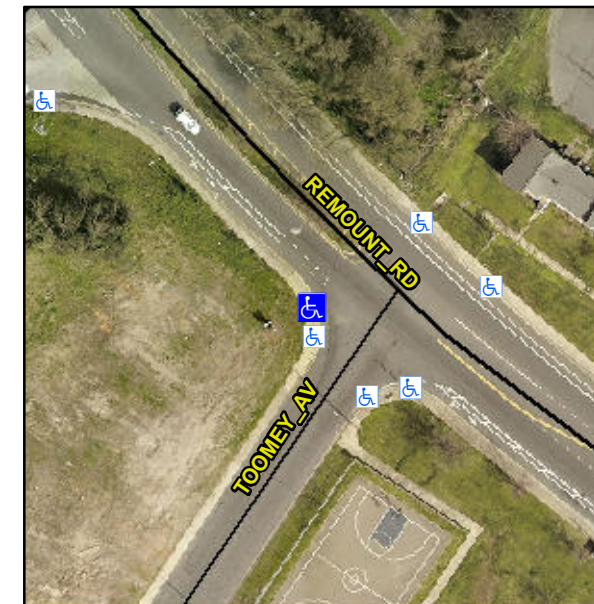
**Not Found, R304.5.1, R304.2.2, R304.5.3**

Compliance	Description	Data	Compliance	Description	Data
N/A	Ramp Length (in)	60.0	No	Ramp Slope (%)	8.5
No	Ramp Width (in)	42.0	No	Ramp XSlope (%)	4.3
N/A	Flare Type LT	N/A	N/A	Flare Type RT	N/A
N/A	Flare Slope LT (%)	N/A	N/A	Flare Slope RT (%)	N/A
N/A	Flare Traversable LT?	N/A	N/A	Flare Traversable RT?	N/A
N/A	Landing Length (in)	N/A	N/A	DWS Provided?	N/A
N/A	Landing Width (in)	N/A	N/A	DWS Contrast?	N/A
N/A	Landing Slope (%)	N/A	N/A	DWS Length (in)	N/A
N/A	Landing X Slope (%)	N/A	N/A	DWS Full Width?	N/A
N/A	Landing Curb? (Y/N)	N/A	N/A	DWS Offset (in)	N/A
N/A	Shared Landing?	N/A			
N/A	Gutter Ponding?	N/A	N/A	Gutter Slope (%)	N/A
N/A	Gutter Lip Ht (in)	N/A	N/A	Gutter X Slope (%)	N/A
N/A	Painted X Walk1?	No	N/A	Painted X Walk2?	N/A
	X Walk 1 Direction	To NE		X Walk 2 Direction	N/A
N/A	X Walk 1 Width (in)	N/A	N/A	X Walk 2 Width (in)	N/A
	X Walk 1 Slope (%)	1.0		X Walk 2 Slope (%)	N/A
	X Walk 1 X Slope (%)	3.8		X Walk 2 X Slope (%)	N/A

N/A	Ramp inside XWalk1?	N/A	N/A	Ramp inside XWalk2?	N/A
	Road Slope (%)	N/A	N/A	Clear Space?	N/A
	Road X Slope (%)	N/A	N/A	Clear Space to XWalk (in)	N/A
N/A	Any Obstructions?	N/A	N/A	Storm Grate/Utility Hazard?	N/A
	Obstruction Type			Storm Grate/Utility Type	
		N/A			N/A
			Yes	Surface Condition? (G/P)	Good

**Remove & Replace Entire Ramp.**
