# Access Compliance Report

## Public Rights-of-Way

### (Curb Ramps)

Intersection ID: 47643	Main Street: BAMBURGH CT	Cross Street: WESTON WOODS LN	Location: NW
ADA ID: AA68E09ADB03	Ramp Type: PerpDiag	Initial Pass/Fail: Fail	Overall Compliance: No
Severity Score: 37.5			
Codes/Mitigation Info/Possible Solution		Field Measurements/Component Compliance

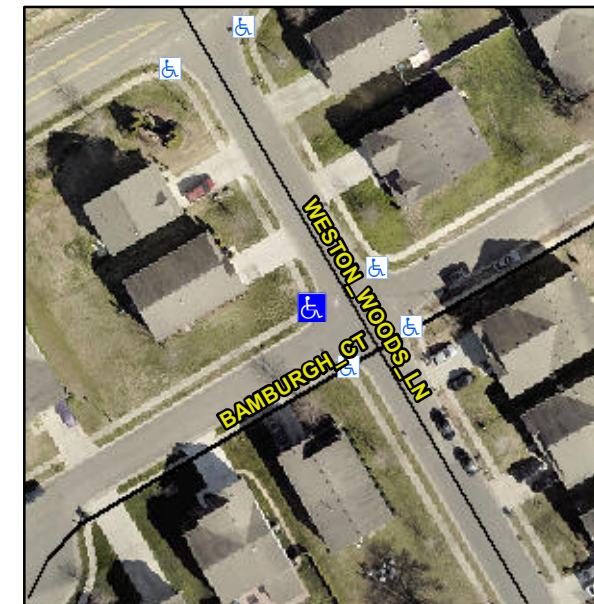
**Not Found, R304.2.2, R304.5.3**

Compliance	Description	Data	Compliance	Description	Data
N/A	Ramp Length (in)	47.0	No	Ramp Slope (%)	9.4
Yes	Ramp Width (in)	48.0	No	Ramp XSlope (%)	9.9
N/A	Flare Type LT	N/A	N/A	Flare Type RT	N/A
N/A	Flare Slope LT (%)	N/A	N/A	Flare Slope RT (%)	N/A
N/A	Flare Traversable LT?	N/A	N/A	Flare Traversable RT?	N/A
N/A	Landing Length (in)	N/A	N/A	DWS Provided?	N/A
N/A	Landing Width (in)	N/A	N/A	DWS Contrast?	N/A
N/A	Landing Slope (%)	N/A	N/A	DWS Length (in)	N/A
N/A	Landing X Slope (%)	N/A	N/A	DWS Full Width?	N/A
N/A	Landing Curb? (Y/N)	N/A	N/A	DWS Offset (in)	N/A
N/A	Shared Landing?	N/A			
N/A	Gutter Ponding?	N/A	N/A	Gutter Slope (%)	N/A
N/A	Gutter Lip Ht (in)	N/A	N/A	Gutter X Slope (%)	N/A
N/A	Painted X Walk1?	No	N/A	Painted X Walk2?	No
	X Walk 1 Direction	To SE		X Walk 2 Direction	To NE
N/A	X Walk 1 Width (in)	N/A	N/A	X Walk 2 Width (in)	N/A
	X Walk 1 Slope (%)	1.5		X Walk 2 Slope (%)	5.6
	X Walk 1 X Slope (%)	6.7		X Walk 2 X Slope (%)	2.2

N/A	Ramp inside XWalk1?	N/A	N/A	Ramp inside XWalk2?	N/A
	Road Slope (%)	4.6	N/A	Clear Space?	N/A
	Road X Slope (%)	5.6	N/A	Clear Space to XWalk (in)	N/A
N/A	Any Obstructions?	N/A	N/A	Storm Grate/Utility Hazard?	N/A
	Obstruction Type			Storm Grate/Utility Type	
		N/A			N/A
		Yes		Surface Condition? (G/P)	Good

**Remove & Replace Curb Ramp With Two New Directional Ramps or Equivalent.**
