## **Access Compliance Report Public Rights-of-Way** (Curb Ramps)

Main Street: ARCHDALE DR Intersection ID: 19986 **Cross Street: SOUTH BV** Location: NW Initial Pass/Fail: Fail **Overall Compliance: No ADA ID: AA6CFC5BB8FB** Ramp Type: Combination2 Severity Score: 13.75

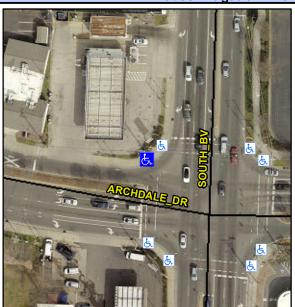
"	Fossible Solution
	Possible Solutions:
	Remove & Replace Entire Ramp.
	Surveyor Notes:
	N/A
	PROW/ADA:
	Not Found, R304.5.3, R304.3.2
ķ	
_
