## **Access Compliance Report Public Rights-of-Way** (Curb Ramps)

Intersection ID: 10038508 Main Street: SPEER\_BV Cross Street: PIEDMONT\_PARK\_DR Location: N **Overall Compliance: No** ADA ID: AA755FA686B4 Ramp Type: Directional1 Initial Pass/Fail: Pass **Severity Score:** 0.25

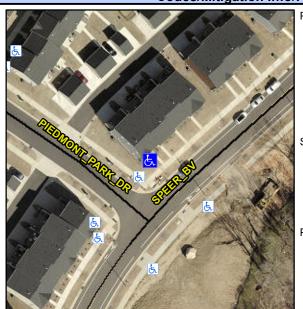
Field Measurements/Component Compliance							
Compl	iance Description	Data	Comp	liance Description	Data		
N/A	Ramp Length (in)	70.0	Yes	Grade Break?	Yes		
Yes	Ramp Width (in)	70.0	Yes	Grade Break Slope (%)	2.3		
Yes	Ramp Slope (%)	5.0	No	Grade Break XSlope (%)	2.5		
No	Ramp XSlope (%)	2.6					
Yes	Flare Type LT	N/A	Yes	Flare Type RT	N/A		
N/A	Flare Slope LT (%)	N/A	N/A	Flare Slope RT (%)	N/A		
N/A	Flare Traversable LT?	No	N/A	Flare Traversable RT?	No		
Yes	Landing Length (in)	70.0	Yes	DWS Provided?	Yes		
Yes	Landing Width (in)	70.0	Yes	DWS Contrast?	Yes		
Yes	Landing Slope (%)	0.1	Yes	DWS Length (in)	24.0		
Yes	Landing X Slope (%)	1.5	Yes	DWS Full Width?	Yes		
N/A	Landing Curb? (Y/N)	No	No	DWS Offset LT (in)	12.0		
N/A	Shared Landing?	Yes	Yes	DWS Offset RT (in)	27.5		
Yes	Gutter Ponding?	No	Yes	Gutter Slope (%)	1.4		
Yes	Gutter Lip Ht (in)	0.0	Yes	Gutter X Slope (%)	1.2		
N/A	Painted X Walk1?	No		Road Slope (%)	2.7

X Walk 1 Direction	To SE		Road X Slope (%)	2.1		
	X Walk 1 Width (in)	N/A		Clear Space?	Yes		
	X Walk 1 Slope (%)	2.7	N/A	Clear Space to XWalk (in)	N/A		
	X Walk 1 X Slope (%)	2.1	Yes	Storm Grate/Utility Hazard?	No		
N/A	Ramp inside XWalk1?	N/A		Storm Grate/Utility Type			
Yes	Any Obstructions?	No			N/A		
	Obstruction Type		Yes	Surface Condition? (G/P)	Good		
		N/A	N/A	Curb Slope (%)	5.4

Possible Solution	
Possible Solutions:	Co
Remove & Replace Entire Ramp.	N/A
·	Yes
	Yes
	No
	Yes
	N/A
Surveyor Notes:	N/A
N/A	Yes
	Yes
	Yes
	Yes
PROW/ADA:	N/A
R304.5.3, R305.2	N/A
·	Yes
	Yes
	N/A

Total Cost:	\$ 1600.00
