# Access Compliance Report

## Public Rights-of-Way (Curb Ramps)

Intersection ID: N/A	Main Street: AGNEW_DR	Cross Street: SOLAR_WY	Location: SE
ADA ID: AA77A2784505	Ramp Type: Perp	Initial Pass/Fail: Fail	Overall Compliance: No
Codes/Mitigation Info/Possible Solution		Field Measurements/Component Compliance

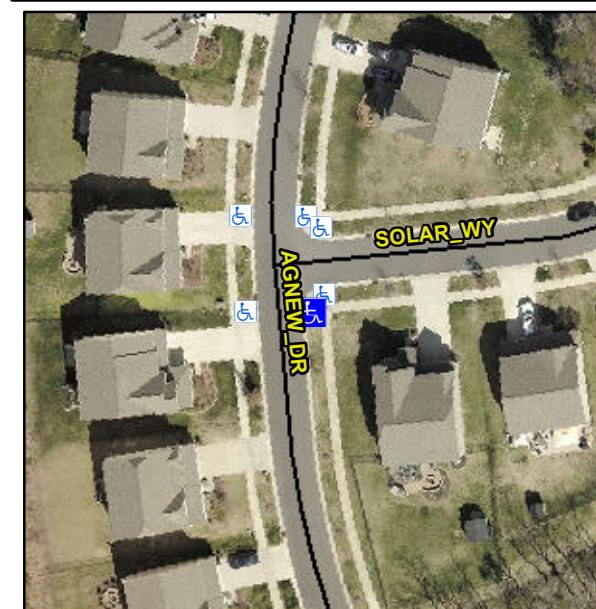
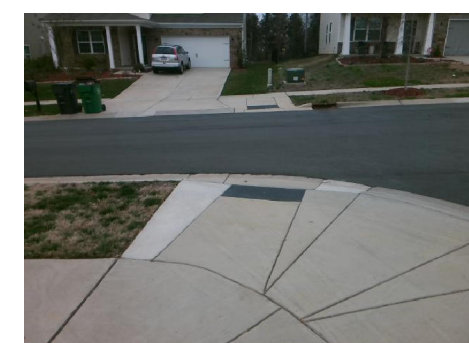
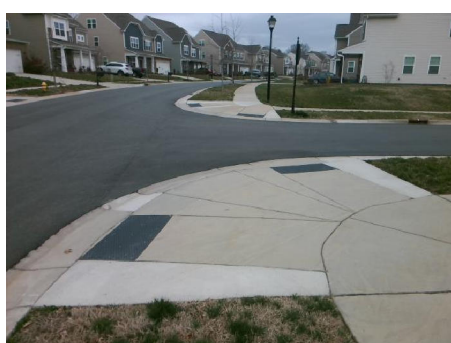
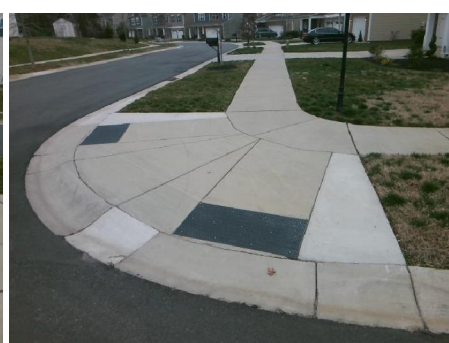
**Not Found, R304.5.1, R304.5.3**

Compliance	Description	Data	Compliance	Description	Data
N/A	Ramp Length (in)	98.0	Yes	Ramp Slope (%)	5.2
No	Ramp Width (in)	45.5	No	Ramp XSlope (%)	5.2
N/A	Flare Type LT	N/A	N/A	Flare Type RT	N/A
N/A	Flare Slope LT (%)	N/A	N/A	Flare Slope RT (%)	N/A
N/A	Flare Traversable LT?	N/A	N/A	Flare Traversable RT?	N/A
N/A	Landing Length (in)	N/A	N/A	DWS Provided?	N/A
N/A	Landing Width (in)	N/A	N/A	DWS Contrast?	N/A
N/A	Landing Slope (%)	N/A	N/A	DWS Length (in)	N/A
N/A	Landing X Slope (%)	N/A	N/A	DWS Full Width?	N/A
N/A	Landing Curb? (Y/N)	N/A	N/A	DWS Offset (in)	N/A
N/A	Shared Landing?	N/A			
N/A	Gutter Ponding?	N/A	N/A	Gutter Slope (%)	N/A
N/A	Gutter Lip Ht (in)	N/A	N/A	Gutter X Slope (%)	N/A
N/A	Painted X Walk1?	No	N/A	Painted X Walk2?	N/A
	X Walk 1 Direction	To W		X Walk 2 Direction	N/A
N/A	X Walk 1 Width (in)	N/A	N/A	X Walk 2 Width (in)	N/A
	X Walk 1 Slope (%)	3.9		X Walk 2 Slope (%)	N/A
	X Walk 1 X Slope (%)	3.1		X Walk 2 X Slope (%)	N/A

N/A	Ramp inside XWalk1?	N/A	N/A	Ramp inside XWalk2?	N/A
	Road Slope (%)	N/A	N/A	Clear Space?	N/A
	Road X Slope (%)	N/A	N/A	Clear Space to XWalk (in)	N/A
N/A	Any Obstructions?	N/A	N/A	Storm Grate/Utility Hazard?	N/A
	Obstruction Type			Storm Grate/Utility Type	
		N/A			N/A
			Yes	Surface Condition? (G/P)	Good

**Remove & Replace Entire Ramp.**

Total Cost: \$ 1850.00
