# Access Compliance Report

## Public Rights-of-Way

### (Curb Ramps)

| Intersection ID: 11322 | Main Street: N_GRAHAM_ST | Cross Street: W_10TH_ST | Location: | E |

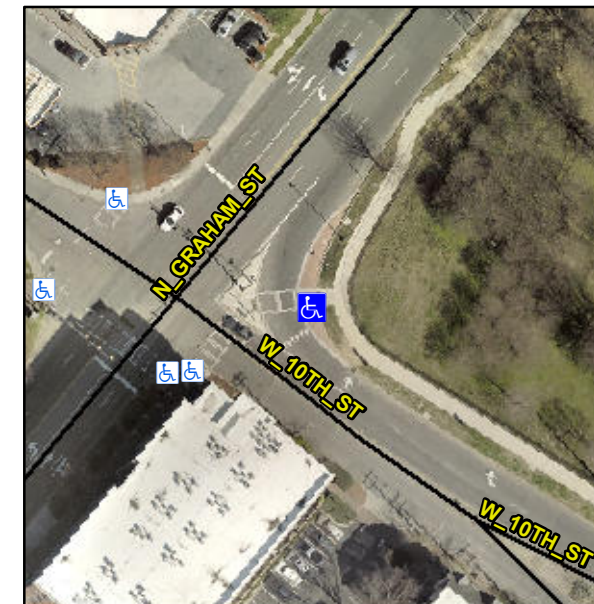
| ADA ID: AA787D617BB2 | Ramp Type: Perp | Initial Pass/Fail: Fail | Overall Compliance: No | Severity Score: 25 |

**R304.5.3**

| Compliance | Description | Data | Compliance | Description | Data |
|---|---|---|---|---|---|
| Yes | Ramp Width (in) | 73.0 | No | Ramp XSlope (%) | 8.2 |

**Remove & Replace Entire Ramp.**

**\$ 1850.00**
