# Access Compliance Report

## Public Rights-of-Way

### (Curb Ramps)

Intersection ID: 53191	Main Street: JOHNSTON_OEHLER_PRIVATE_DR	Cross Street: JOHNSTON_OEHLER_RD	Location: SE
ADA ID: AA7A76FF8680	Ramp Type: BlendTrans1	Initial Pass/Fail: Fail	Overall Compliance: No
		Severity Score: 1.25

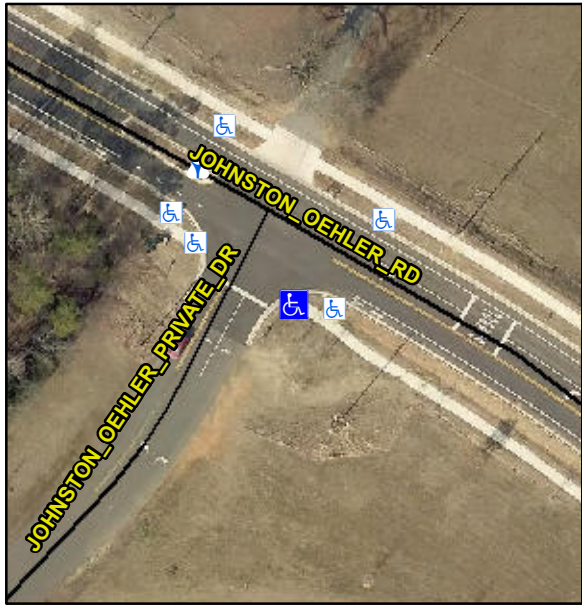
Possible Solutions:		Compliance	Description	Data	Compliance	Description	Data
	Remove & Replace Curb Ramp With Two New Directional Ramps or Equivalent.		N/A	Ramp Length (in)	104.0	Yes	BlendTrans Slope (%)	4.2
			Yes	Ramp Width (in)	60.0	No	BlendTrans XSlope (%)	2.8
			N/A	Flare Type	LT_Curbed_NoWalkSurface	N/A	Flare Type	RT_Curbed_NoWalkSurface
			N/A	Flare Slope LT (%)	N/A	N/A	Flare Slope RT (%)	N/A
			N/A	Flare Traversable LT?	No	N/A	Flare Traversable RT?	No
			N/A	Landing Length (in)	80.0	N/A	DWS Provided?	Yes
			N/A	Landing Width (in)	60.0	N/A	DWS Contrast?	Yes
			N/A	Landing Slope (%)	0.4	N/A	DWS Length (in)	24.0
			N/A	Landing X Slope (%)	1.6	N/A	DWS Full Width?	Yes
Surveyor Notes:		N/A	N/A	Landing Curb? (Y/N)	No	N/A	DWS Offset (in)	N/A
PROW/ADA:		R304.5.3	N/A	Shared Landing?	No			
			N/A	Gutter Ponding?	Yes	N/A	Gutter Slope (%)	1.6

N/A	Gutter Lip Ht (in)	0.0	N/A	Gutter X Slope (%)	0.5
			N/A	Painted X Walk1?	No	N/A	Painted X Walk2?	N/A
				X Walk 1 Direction	To NW		X Walk 2 Direction	N/A
				X Walk 1 Width (in)	N/A		X Walk 2 Width (in)	N/A
				X Walk 1 Slope (%)	1.0		X Walk 2 Slope (%)	N/A
				X Walk 1 X Slope (%)	0.1		X Walk 2 X Slope (%)	N/A
			N/A	Ramp inside XWalk1?	N/A	N/A	Ramp inside XWalk2?	N/A
				Road Slope (%)	0.1		Clear Space?	Yes
				Road X Slope (%)	1.0	N/A	Clear Space to XWalk (in)	N/A
			N/A	Any Obstructions?	No	N/A	Storm Grate/Utility Hazard?	No
				Obstruction Type			Storm Grate/Utility Type	
					N/A			N/A
						Yes	Surface Condition? (G/P)	Good
						N/A	Curb Slope (%)	N/A
