Access Compliance Report

Public Rights-of-Way

(Curb Ramps)

Intersection ID: 6611	Main Street: N_TRYON_ST	Cross Street: W_ROCKY_RIVER_RD	Location: E
ADA ID: AA7BE144751B	Ramp Type: BlendTrans1	Initial Pass/Fail: Pass	Overall Compliance: No
		Severity Score: 0

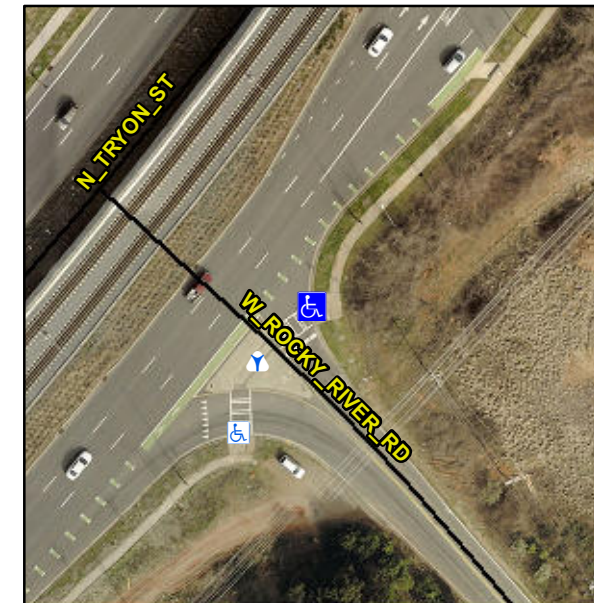
Not Found, R305.2

Compliance	Description	Data	Compliance	Description	Data
N/A	Ramp Length (in)	97.0	Yes	BlendTrans Slope (%)	4.5
Yes	Ramp Width (in)	48.0	Yes	BlendTrans XSlope (%)	1.2
N/A	Flare Type LT	Sloped	N/A	Flare Type RT	Sloped
N/A	Flare Slope LT (%)	3.8	N/A	Flare Slope RT (%)	4.6
N/A	Flare Traversable LT?	No	N/A	Flare Traversable RT?	No
Yes	Landing Length (in)	72.0	Yes	DWS Provided?	Yes
Yes	Landing Width (in)	48.0	Yes	DWS Contrast?	Yes
Yes	Landing Slope (%)	1.5	Yes	DWS Length (in)	24.0
Yes	Landing X Slope (%)	0.3	Yes	DWS Full Width?	Yes
N/A	Landing Curb? (Y/N)	No	No	DWS Offset (in)	4.0
N/A	Shared Landing?	No			
Yes	Gutter Ponding?	No	Yes	Gutter Slope (%)	1.6
Yes	Gutter Lip Ht (in)	0.0	Yes	Gutter X Slope (%)	0.2
N/A	Painted X Walk1?	No	N/A	Painted X Walk2?	Yes
	X Walk 1 Direction	To NW		X Walk 2 Direction	To SW
	X Walk 1 Width (in)	N/A		X Walk 2 Width (in)	113.0
	X Walk 1 Slope (%)	0.8		X Walk 2 Slope (%)	1.4
	X Walk 1 X Slope (%)	0.4		X Walk 2 X Slope (%)	0.3

N/A	Ramp inside XWalk1?	N/A	Yes	Ramp inside XWalk2?	Yes
	Road Slope (%)	0.0		Clear Space?	Yes
	Road X Slope (%)	0.0	N/A	Clear Space to XWalk (in)	N/A
Yes	Any Obstructions?	No	Yes	Storm Grate/Utility Hazard?	No
	Obstruction Type			Storm Grate/Utility Type	
		N/A			N/A
			Yes	Surface Condition? (G/P)	Good
			No	Curb Slope (%)	16.2

Possible Solutions:

Remove & Replace Curb Ramp With Two New Directional Ramps or Equivalent.
