Access Compliance Report Public Rights-of-Way (Curb Ramps)

Intersection ID: 47138 Main Street: SAVANNAH_HILLS_DR Cross Street: HABITAT_MANOR_DR Location: W

ADA ID: AA8697BFD18F Ramp Type: BlendTrans1 Initial Pass/Fail: Fail Overall Compliance: No Severity Score: 12.5

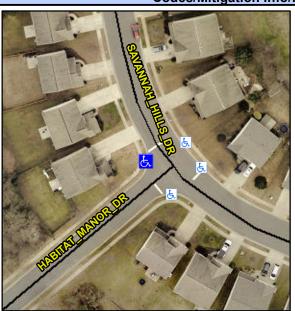
PROW/ADA:
Not Found, R304.5.3

| | Field Measure | ements/C | ompo | nent Compliance | |
|---|---|---|---|---|---|
| Yes | Ramp Width (in) | 58.0 | No | BlendTrans XSlope (%) | 5.8 |
| | | | No | Curb Slope (%) | 15.4 |

Remove & Replace Curb Ramp With
Two New Directional Ramps or
Equivalent.

Total Cost: \$ 3200.00
