# Access Compliance Report

## Public Rights-of-Way

### (Curb Ramps)

Intersection ID: 16558	Main Street: BUCKNELL_AV	Cross Street: QUEENS_RD_WEST	Location: SE
ADA ID: AA8924EFFA08	Ramp Type: BlendTrans2	Initial Pass/Fail: Fail	Overall Compliance: No
Severity Score: 1.25			
Codes/Mitigation Info/Possible Solution		Field Measurements/Component Compliance

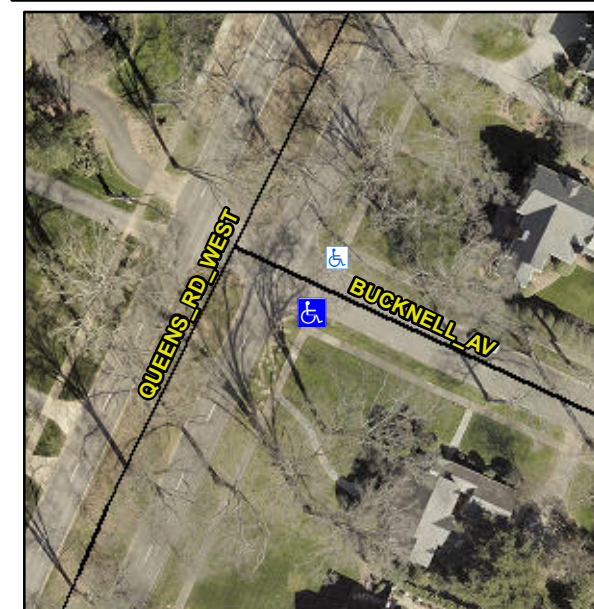
**Not Found, R304.5.3**

Compliance	Description	Data	Compliance	Description	Data
N/A	Ramp Length (in)	57.0	Yes	BlendTrans Slope (%)	1.0
Yes	Ramp Width (in)	60.0	No	BlendTrans XSlope (%)	2.2
N/A	Flare Type LT	N/A	N/A	Flare Type RT	N/A
N/A	Flare Slope LT (%)	N/A	N/A	Flare Slope RT (%)	N/A
N/A	Flare Traversable LT?	N/A	N/A	Flare Traversable RT?	N/A
N/A	Landing Length (in)	N/A	N/A	DWS Provided?	N/A
N/A	Landing Width (in)	N/A	N/A	DWS Contrast?	N/A
N/A	Landing Slope (%)	N/A	N/A	DWS Length (in)	N/A
N/A	Landing X Slope (%)	N/A	N/A	DWS Full Width?	N/A
N/A	Landing Curb? (Y/N)	N/A	N/A	DWS Offset (in)	N/A
N/A	Shared Landing?	N/A			
N/A	Gutter Ponding?	N/A	N/A	Gutter Slope (%)	N/A
N/A	Gutter Lip Ht (in)	N/A	N/A	Gutter X Slope (%)	N/A
N/A	Painted X Walk1?	No	N/A	Painted X Walk2?	N/A
	X Walk 1 Direction	To NE		X Walk 2 Direction	N/A
	X Walk 1 Width (in)	N/A		X Walk 2 Width (in)	N/A
	X Walk 1 Slope (%)	4.0		X Walk 2 Slope (%)	N/A
	X Walk 1 X Slope (%)	0.9		X Walk 2 X Slope (%)	N/A

N/A	Ramp inside XWalk1?	N/A	N/A	Ramp inside XWalk2?	N/A
	Road Slope (%)	0.9		Clear Space?	N/A
	Road X Slope (%)	4.0	N/A	Clear Space to XWalk (in)	N/A
N/A	Any Obstructions?	N/A	N/A	Storm Grate/Utility Hazard?	N/A
	Obstruction Type			Storm Grate/Utility Type	
		N/A			N/A
			Yes	Surface Condition? (G/P)	Good
			No	Curb Slope (%)	32.1

**Remove & Replace Curb Ramp With Two New Directional Ramps or Equivalent.**
