# Access Compliance Report

## Public Rights-of-Way

### (Curb Ramps)

| Intersection ID: 47835 | Main Street: CAMP_VERDE_LN | Cross Street: CACTUS_VALLEY_RD | Location: SE |

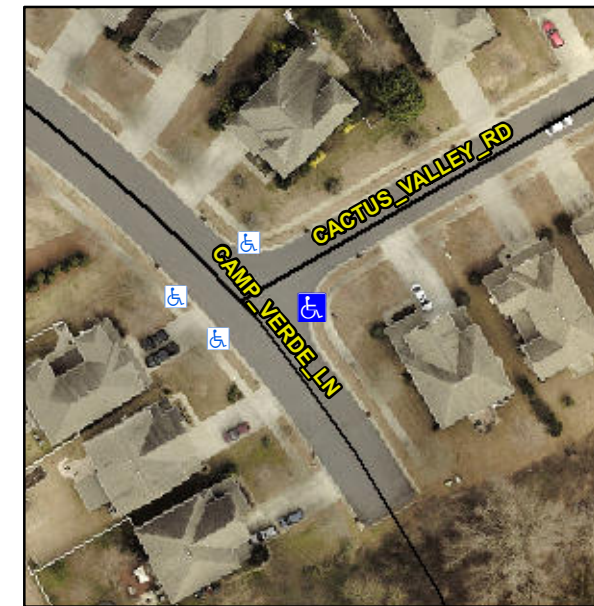
**Not Found, R304.5.1, R304.5.3**

| Compliance | Description | Data | Compliance | Description | Data |
|---|---|---|---|---|---|
| N/A | Ramp Length (in) | 58.0 | Yes | Ramp Slope (%) | 5.5 |
| No | Ramp Width (in) | 47.0 | No | Ramp XSlope (%) | 2.4 |

**Remove & Replace Curb Ramp With Two New Directional Ramps or Equivalent.**
