Access Compliance Report

Public Rights-of-Way

(Curb Ramps)

Intersection ID: 10037289	Main Street: SARDIS_RD_NORTH	Cross Street: N/A	Location: SE
ADA ID: AAA3E849E229	Ramp Type: Perp	Initial Pass/Fail: Fail	Overall Compliance: No
Severity Score: 12.5			
Codes/Mitigation Info/Possible Solution		Field Measurements/Component Compliance

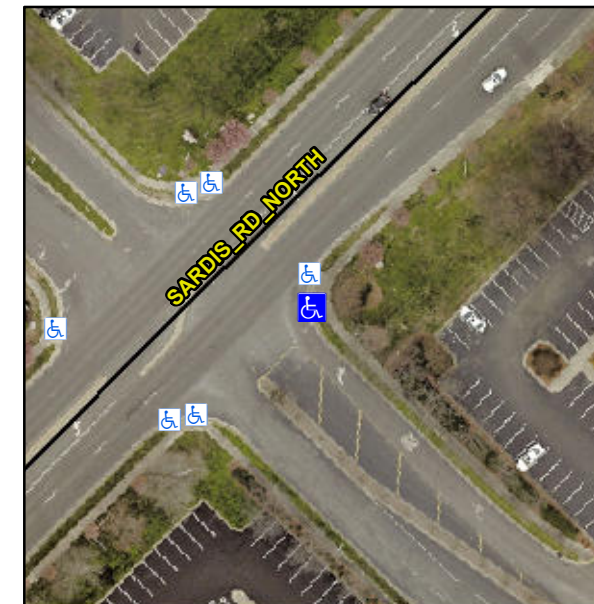
Not Found, R304.2.2

Compliance	Description	Data	Compliance	Description	Data
N/A	Ramp Length (in)	60.0	No	Ramp Slope (%)	8.9
Yes	Ramp Width (in)	48.0	Yes	Ramp XSlope (%)	0.5
N/A	Flare Type LT	N/A	N/A	Flare Type RT	N/A
N/A	Flare Slope LT (%)	N/A	N/A	Flare Slope RT (%)	N/A
N/A	Flare Traversable LT?	N/A	N/A	Flare Traversable RT?	N/A
N/A	Landing Length (in)	N/A	N/A	DWS Provided?	N/A
N/A	Landing Width (in)	N/A	N/A	DWS Contrast?	N/A
N/A	Landing Slope (%)	N/A	N/A	DWS Length (in)	N/A
N/A	Landing X Slope (%)	N/A	N/A	DWS Full Width?	N/A
N/A	Landing Curb? (Y/N)	N/A	N/A	DWS Offset (in)	N/A
N/A	Shared Landing?	N/A			
N/A	Gutter Ponding?	N/A	N/A	Gutter Slope (%)	N/A
N/A	Gutter Lip Ht (in)	N/A	N/A	Gutter X Slope (%)	N/A
N/A	Painted X Walk1?	No	N/A	Painted X Walk2?	N/A
	X Walk 1 Direction	To SW		X Walk 2 Direction	N/A
N/A	X Walk 1 Width (in)	N/A	N/A	X Walk 2 Width (in)	N/A
	X Walk 1 Slope (%)	1.0		X Walk 2 Slope (%)	N/A
	X Walk 1 X Slope (%)	0.4		X Walk 2 X Slope (%)	N/A

Remove & Replace Entire Ramp.

Total Cost: \$ 1850.00
