Access Compliance Report

Public Rights-of-Way

(Curb Ramps)

Intersection ID: 10247	Main Street: BURTON_ST	Cross Street: WHISNANT_ST	Location: S
ADA ID: AAC0EDF3323B	Ramp Type: Perp	Initial Pass/Fail: Fail	Overall Compliance: No
		Severity Score: 10

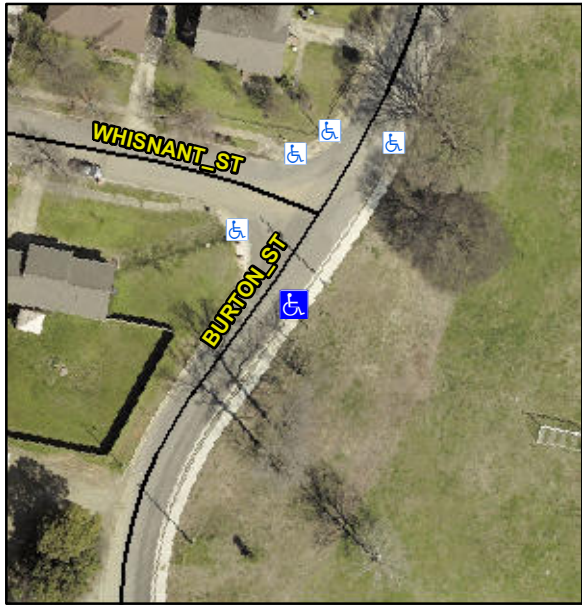
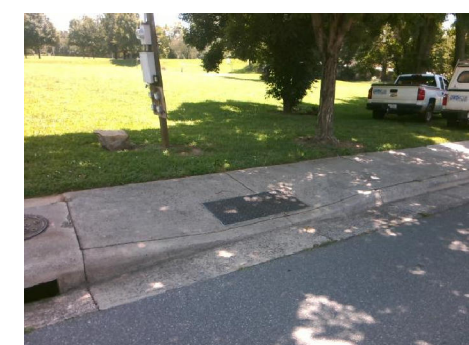
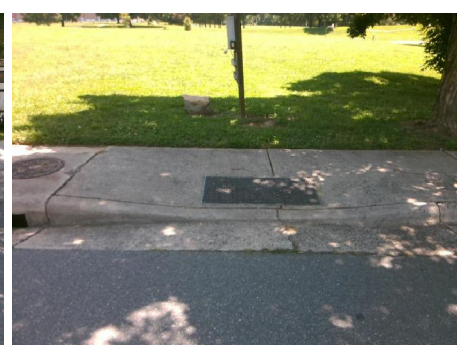
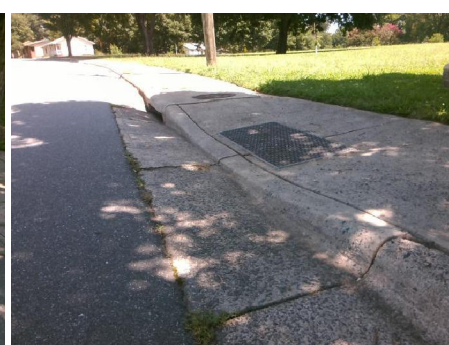
Possible Solutions:		Compliance	Description	Data	Compliance	Description	Data
	Remove & Replace Entire Ramp.		N/A	Ramp Length (in)	63.0	Yes	Ramp Slope (%)	7.4
			No	Ramp Width (in)	46.0	Yes	Ramp XSlope (%)	3.2
			N/A	Flare Type LT	N/A	N/A	Flare Type RT	N/A
			N/A	Flare Slope LT (%)	N/A	N/A	Flare Slope RT (%)	N/A
			N/A	Flare Traversable LT?	N/A	N/A	Flare Traversable RT?	N/A
			N/A	Landing Length (in)	N/A	N/A	DWS Provided?	N/A
			N/A	Landing Width (in)	N/A	N/A	DWS Contrast?	N/A
			N/A	Landing Slope (%)	N/A	N/A	DWS Length (in)	N/A
			N/A	Landing X Slope (%)	N/A	N/A	DWS Full Width?	N/A
<p>Surveyor Notes:</p> <p>N/A</p> <p>PROW/ADA:</p> <p>Not Found, R304.5.1</p>			N/A	Landing Curb? (Y/N)	N/A	N/A	DWS Offset (in)	N/A
			N/A	Shared Landing?	N/A			
			N/A	Gutter Ponding?	N/A	N/A	Gutter Slope (%)	N/A
			N/A	Gutter Lip Ht (in)	N/A	N/A	Gutter X Slope (%)	N/A

N/A	Painted X Walk1?	No	N/A	Painted X Walk2?	N/A
				X Walk 1 Direction	To NW		X Walk 2 Direction	N/A
			N/A	X Walk 1 Width (in)	N/A	N/A	X Walk 2 Width (in)	N/A
				X Walk 1 Slope (%)	5.8		X Walk 2 Slope (%)	N/A
				X Walk 1 X Slope (%)	3.8		X Walk 2 X Slope (%)	N/A
			N/A	Ramp inside XWalk1?	N/A	N/A	Ramp inside XWalk2?	N/A
			Road Slope (%)	N/A	N/A	Clear Space?	N/A	
			Road X Slope (%)	N/A	N/A	Clear Space to XWalk (in)	N/A	
		N/A	Any Obstructions?	N/A	N/A	Storm Grate/Utility Hazard?	N/A	
			Obstruction Type			Storm Grate/Utility Type		
					N/A		N/A	
						Yes	Surface Condition? (G/P)	Good
		</
