Access Compliance Report

Public Rights-of-Way

(Curb Ramps)

| Intersection ID: N/A | Main Street: KINGS PARADE BV | Cross Street: N/A | Location: W |

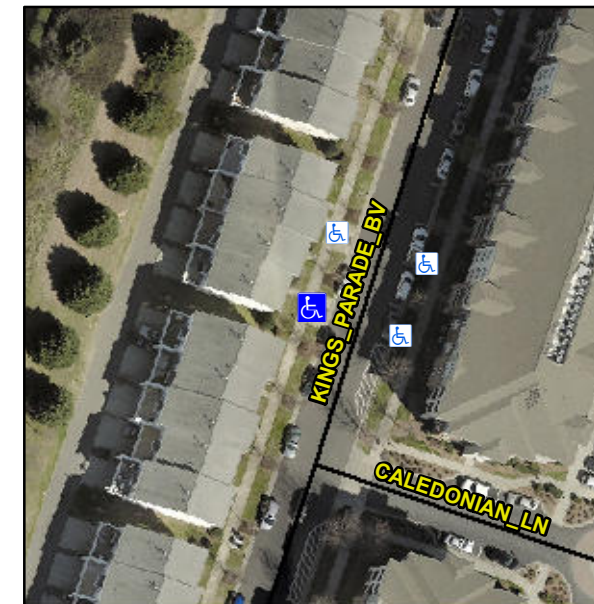
| ADA ID: AAD3FA7E960A | Ramp Type: Perp | Initial Pass/Fail: Fail | Overall Compliance: No |
| | | Severity Score: 12.5 | |

R304.2.2

| Compliance | Description | Data | Compliance | Description | Data |
|---|---|---|---|---|---|
| N/A | Ramp Length (in) | 97.0 | No | Ramp Slope (%) | 9.0 |

Remove & Replace Entire Ramp.

\$ 1850.00
