Access Compliance Report

Public Rights-of-Way

(Curb Ramps)

Intersection ID: N/A	Main Street: INDEPENDENCE_RD	Cross Street: BUICK_DR	Location: NE
ADA ID: AAE9902B0F68	Ramp Type: PerpDiag	Initial Pass/Fail: Fail	Overall Compliance: No
		Severity Score: 12.5

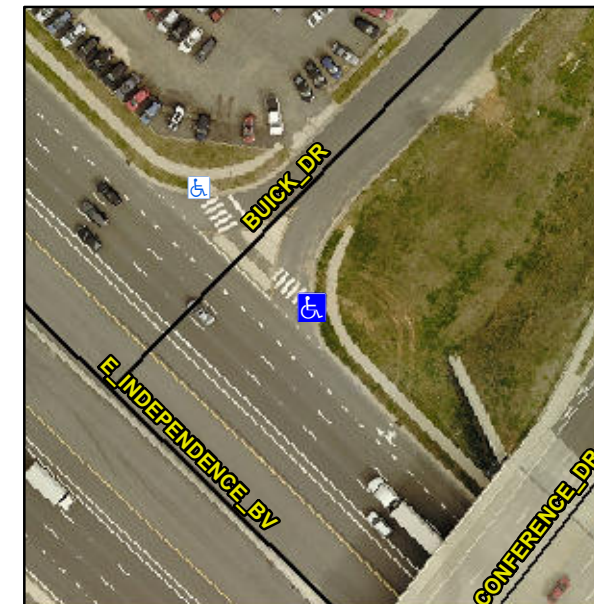
Not Found, R304.2.2

Compliance	Description	Data	Compliance	Description	Data
N/A	Ramp Length (in)	71.0	No	Ramp Slope (%)	9.2
Yes	Ramp Width (in)	48.0	Yes	Ramp XSlope (%)	0.2
N/A	Flare Type LT	N/A	N/A	Flare Type RT	N/A
N/A	Flare Slope LT (%)	N/A	N/A	Flare Slope RT (%)	N/A
N/A	Flare Traversable LT?	N/A	N/A	Flare Traversable RT?	N/A
N/A	Landing Length (in)	N/A	N/A	DWS Provided?	N/A
N/A	Landing Width (in)	N/A	N/A	DWS Contrast?	N/A
N/A	Landing Slope (%)	N/A	N/A	DWS Length (in)	N/A
N/A	Landing X Slope (%)	N/A	N/A	DWS Full Width?	N/A
N/A	Landing Curb? (Y/N)	N/A	N/A	DWS Offset (in)	N/A
N/A	Shared Landing?	N/A			
N/A	Gutter Ponding?	N/A	N/A	Gutter Slope (%)	N/A
N/A	Gutter Lip Ht (in)	N/A	N/A	Gutter X Slope (%)	N/A
N/A	Painted X Walk1?	Yes	N/A	Painted X Walk2?	No
	X Walk 1 Direction	To NW		X Walk 2 Direction	To SW
N/A	X Walk 1 Width (in)	119.0	N/A	X Walk 2 Width (in)	N/A
	X Walk 1 Slope (%)	4.9		X Walk 2 Slope (%)	3.0
	X Walk 1 X Slope (%)	3.1		X Walk 2 X Slope (%)	3.8

N/A	Ramp inside XWalk1?	Yes	N/A	Ramp inside XWalk2?	N/A
	Road Slope (%)	0.7	N/A	Clear Space?	N/A
	Road X Slope (%)	5.9	N/A	Clear Space to XWalk (in)	N/A
N/A	Any Obstructions?	N/A	N/A	Storm Grate/Utility Hazard?	N/A
	Obstruction Type			Storm Grate/Utility Type	
		N/A			N/A
		Yes		Surface Condition? (G/P)	Good

Remove & Replace Curb Ramp With Two New Directional Ramps or Equivalent.
