Access Compliance Report

Public Rights-of-Way

(Curb Ramps)

Intersection ID: 12413	Main Street: N_BREVARD_ST	Cross Street: E_6TH_ST	Location: W
ADA ID: AAEA12A9A78E	Ramp Type: Perp	Initial Pass/Fail: Pass	Overall Compliance: No
Severity Score: 5			
Codes/Mitigation Info/Possible Solution		Field Measurements/Component Compliance

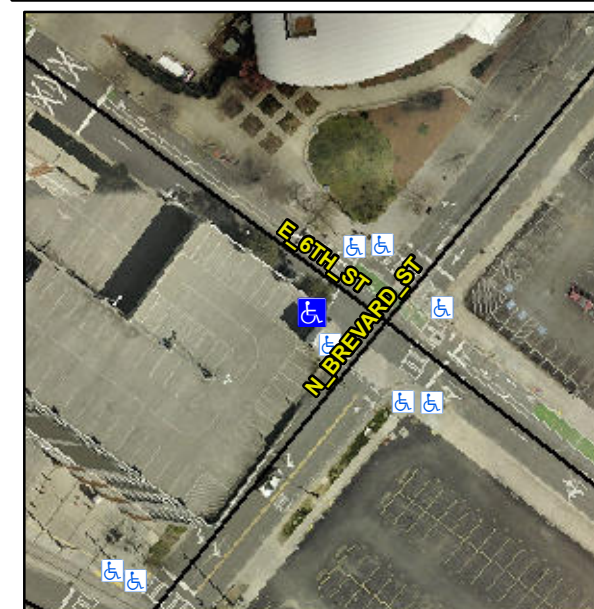
Compliance	Description	Data	Compliance	Description	Data
N/A	Ramp Length (in)	90.0	Yes	Ramp Slope (%)	8.1
Yes	Ramp Width (in)	48.0	Yes	Ramp XSlope (%)	0.8
N/A	Flare Type LT	Sloped	N/A	Flare Type RT	N/A
N/A	Flare Slope LT (%)	4.5	N/A	Flare Slope RT (%)	9.7
N/A	Flare Traversable LT?	Yes	N/A	Flare Traversable RT?	No
Yes	Landing Length (in)	48.0	Yes	DWS Provided?	Yes
Yes	Landing Width (in)	48.0	Yes	DWS Contrast?	Yes
Yes	Landing Slope (%)	0.6	Yes	DWS Length (in)	24.0
Yes	Landing X Slope (%)	0.6	Yes	DWS Full Width?	Yes
N/A	Landing Curb? (Y/N)	No	Yes	DWS Offset (in)	1.5
N/A	Shared Landing?	No			
Yes	Gutter Ponding?	No	No	Gutter Slope (%)	5.2
Yes	Gutter Lip Ht (in)	0.0	Yes	Gutter X Slope (%)	0.1
N/A	Painted X Walk1?	Yes	N/A	Painted X Walk2?	N/A
	X Walk 1 Direction	To NE		X Walk 2 Direction	N/A
N/A	X Walk 1 Width (in)	112.0	N/A	X Walk 2 Width (in)	N/A
	X Walk 1 Slope (%)	2.2		X Walk 2 Slope (%)	N/A
	X Walk 1 X Slope (%)	0.3		X Walk 2 X Slope (%)	N/A

Yes	Ramp inside XWalk1?	Yes	N/A	Ramp inside XWalk2?	N/A
	Road Slope (%)	N/A	N/A	Clear Space?	Yes
	Road X Slope (%)	N/A	N/A	Clear Space to XWalk (in)	N/A
Yes	Any Obstructions?	No	Yes	Storm Grate/Utility Hazard?	No
	Obstruction Type			Storm Grate/Utility Type	
		N/A			N/A
		Yes		Surface Condition? (G/P)	Good

Possible Solutions:

**Remove & Replace Entire Ramp.
Remove & Replace Gutter.**

Not Found, R304.5.4
