Access Compliance Report

Public Rights-of-Way

(Curb Ramps)

Intersection ID: 10025998	Main Street: ELMSTONE_DR	Cross Street: N/A	Location: N
ADA ID: AAED68DD4256	Ramp Type: Perp	Initial Pass/Fail: Pass	Overall Compliance: No
			Severity Score: 20.25

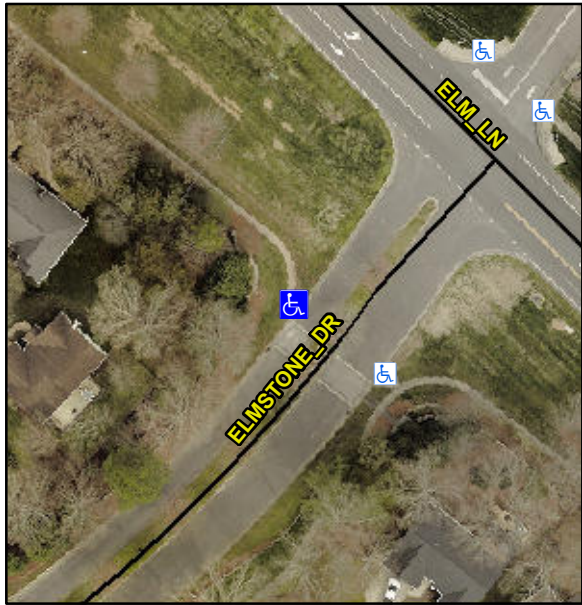
Possible Solutions:		Compliance			Description			Data	
	Remove & Replace Entire Ramp.		N/A	Ramp Length (in)	102.0	Yes	Ramp Slope (%)	5.4		
			Yes	Ramp Width (in)	48.0	No	Ramp XSlope (%)	3.5		
			N/A	Flare Type LT	Sloped	N/A	Flare Type RT	N/A		
			N/A	Flare Slope LT (%)	8.4	Yes	Flare Slope RT (%)	5.7		
			N/A	Flare Traversable LT?	Yes	N/A	Flare Traversable RT?	Yes		
			No	Landing Length (in)	N/A	No	DWS Provided?	No		
			No	Landing Width (in)	N/A	N/A	DWS Contrast?	No		
			No	Landing Slope (%)	N/A	N/A	DWS Length (in)	N/A		
			No	Landing X Slope (%)	N/A	N/A	DWS Full Width?	No		
Surveyor Notes:		N/A	N/A	Landing Curb? (Y/N)	No	N/A	DWS Offset (in)	N/A		
PROW/ADA:		Not Found, R304.5.3, R304.2.1, R304.2.2-Perp, R304.3.2-Para, R305, R302.7	N/A	Shared Landing?	No					
			No	Gutter Ponding?	Yes	Yes	Gutter Slope (%)	3.3		
			Yes	Gutter Lip Ht (in)	0.0	Yes	Gutter X Slope (%)	0.5

N/A	Painted X Walk1?	No	N/A	Painted X Walk2?	N/A		
				X Walk 1 Direction	To SE		X Walk 2 Direction	N/A		
			N/A	X Walk 1 Width (in)	N/A	N/A	X Walk 2 Width (in)	N/A		
				X Walk 1 Slope (%)	7.1		X Walk 2 Slope (%)	N/A		
				X Walk 1 X Slope (%)	0.1		X Walk 2 X Slope (%)	N/A		
			N/A	Ramp inside XWalk1?	N/A	N/A	Ramp inside XWalk2?	N/A		
				Road Slope (%)	N/A	N/A	Clear Space?	Yes		
				Road X Slope (%)	N/A	N/A	Clear Space to XWalk (in)	N/A		
			Yes	Any Obstructions?	No	Yes	Storm Grate/Utility Hazard?	No		
				Obstruction Type			Storm Grate/Utility Type			
						N/A		N/A		
						Yes	Surface Condition? (G/P)	Good
