Access Compliance Report

Public Rights-of-Way

(Curb Ramps)

Intersection ID: 27935	Main Street: PROVIDENCE_COUNTRY_CLUB_DR	Cross Street: ROYAL_LYTHAM_CT	Location: SW
ADA ID: AAF16FA84C84	Ramp Type: Perp	Initial Pass/Fail: Fail	Overall Compliance: No
Severity Score: 1.25			
Codes/Mitigation Info/Possible Solution		Field Measurements/Component Compliance

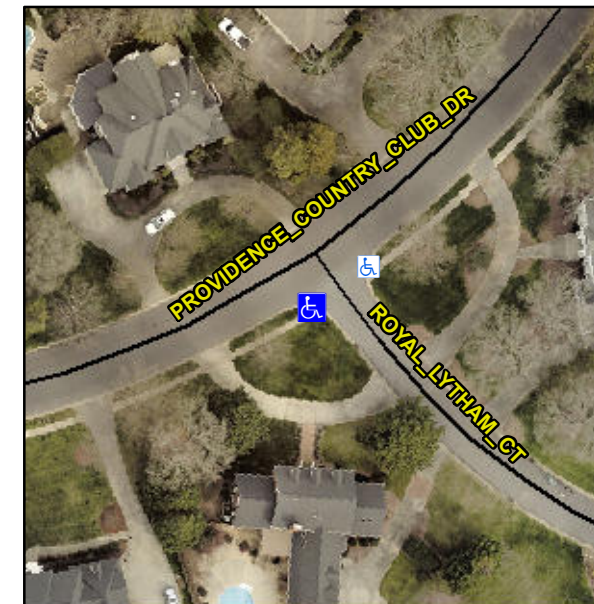
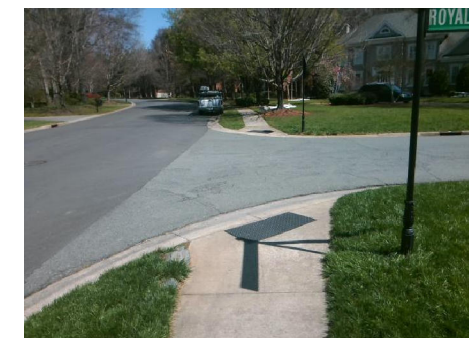
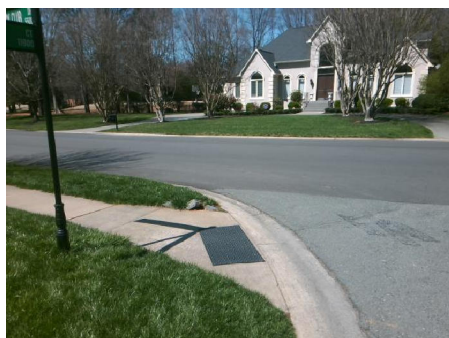
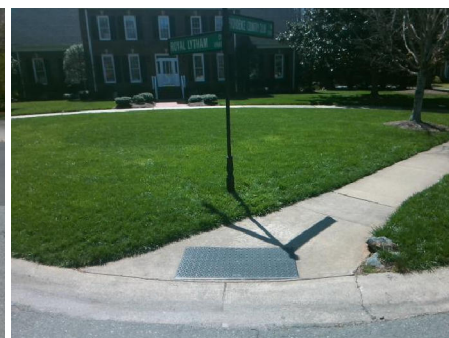
Not Found, R304.5.3

Compliance	Description	Data	Compliance	Description	Data
N/A	Ramp Length (in)	37.0	Yes	Ramp Slope (%)	5.1
Yes	Ramp Width (in)	48.0	No	Ramp XSlope (%)	3.3
N/A	Flare Type LT	N/A	N/A	Flare Type RT	N/A
N/A	Flare Slope LT (%)	N/A	N/A	Flare Slope RT (%)	N/A
N/A	Flare Traversable LT?	N/A	N/A	Flare Traversable RT?	N/A
N/A	Landing Length (in)	N/A	N/A	DWS Provided?	N/A
N/A	Landing Width (in)	N/A	N/A	DWS Contrast?	N/A
N/A	Landing Slope (%)	N/A	N/A	DWS Length (in)	N/A
N/A	Landing X Slope (%)	N/A	N/A	DWS Full Width?	N/A
N/A	Landing Curb? (Y/N)	N/A	N/A	DWS Offset (in)	N/A
N/A	Shared Landing?	N/A			
N/A	Gutter Ponding?	N/A	N/A	Gutter Slope (%)	N/A
N/A	Gutter Lip Ht (in)	N/A	N/A	Gutter X Slope (%)	N/A
N/A	Painted X Walk1?	No	N/A	Painted X Walk2?	N/A
	X Walk 1 Direction	To NE		X Walk 2 Direction	N/A
N/A	X Walk 1 Width (in)	N/A	N/A	X Walk 2 Width (in)	N/A
	X Walk 1 Slope (%)	4.5		X Walk 2 Slope (%)	N/A
	X Walk 1 X Slope (%)	1.5		X Walk 2 X Slope (%)	N/A

N/A	Ramp inside XWalk1?	N/A	N/A	Ramp inside XWalk2?	N/A
	Road Slope (%)	N/A	N/A	Clear Space?	N/A
	Road X Slope (%)	N/A	N/A	Clear Space to XWalk (in)	N/A
N/A	Any Obstructions?	N/A	N/A	Storm Grate/Utility Hazard?	N/A
	Obstruction Type			Storm Grate/Utility Type	
		N/A			N/A
		Yes		Surface Condition? (G/P)	Good

Possible Solutions:

Remove & Replace Entire Ramp.
