Access Compliance Report Public Rights-of-Way (Curb Ramps)

Intersection ID: 29325 Main Street: ELIZABETH_RD Cross Street: IRWIN_VALLEY_CT Location: W

ADA ID: AAF2D2F72254 Ramp Type: BlendTrans1 Initial Pass/Fail: Fail Overall Compliance: No Severity Score: 25

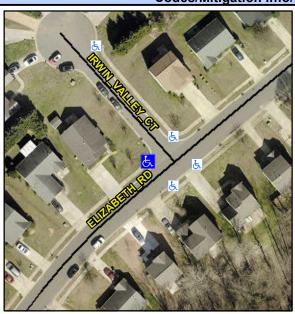
CURB GAP 3.0, NO RT SW

Not Found, R304.5.1, R304.5.3, R302.7

Compliance Description Data Compliance Description Data Yes N/A Ramp Length (in) 35.0 BlendTrans Slope (%) 4.7 No No Ramp Width (in) 46.0 BlendTrans XSlope (%) 3.2 N/A N/A Flare Type LT N/A Flare Type RT N/A N/A Flare Slope LT (%) N/A N/A Flare Slope RT (%) N/A N/A Flare Traversable LT? N/A N/A Flare Traversable RT? N/A N/A N/A N/A DWS Provided? N/A Landing Length (in) N/A Landing Width (in) N/A N/A **DWS Contrast?** N/A N/A N/A N/A Landing Slope (%) DWS Length (in) N/A N/A Landing X Slope (%) N/A N/A DWS Full Width? N/A N/A Landing Curb? (Y/N) N/A N/A DWS Offset (in) N/A N/A N/A Shared Landing? N/A **Gutter Ponding?** N/A N/A Gutter Slope (%) N/A N/A Gutter Lip Ht (in) N/A N/A Gutter X Slope (%) N/A N/A Painted X Walk1? No N/A Painted X Walk2? No X Walk 1 Direction To SE X Walk 2 Direction To NE N/A N/A X Walk 1 Width (in) X Walk 2 Width (in) X Walk 1 Slope (%) X Walk 2 Slope (%) 1.1 4.4 X Walk 1 X Slope (%) 1.9 X Walk 2 X Slope (%) 4.0 N/A N/A Ramp inside XWalk2? N/A N/A Ramp inside XWalk1? Road Slope (%) 5.0 Clear Space? N/A Road X Slope (%) 2.3 N/A Clear Space to XWalk (in) N/A N/A N/A N/A Any Obstructions? Storm Grate/Utility Hazard? N/A **Obstruction Type** Storm Grate/Utility Type N/A N/A No Surface Condition? (G/P) Poor No Curb Slope (%) 16.3

Remove & Replace Curb Ramp With Two New Directional Ramps or Equivalent.
