# Access Compliance Report

## Public Rights-of-Way

### (Curb Ramps)

Intersection ID: 10037289	Main Street: SARDIS_RD_NORTH	Cross Street: N/A	Location: SE
ADA ID: AAFFC3669BD5	Ramp Type: Perp	Initial Pass/Fail: Fail	Overall Compliance: No
Codes/Mitigation Info/Possible Solution		Field Measurements/Component Compliance	
Severity Score: 12.5

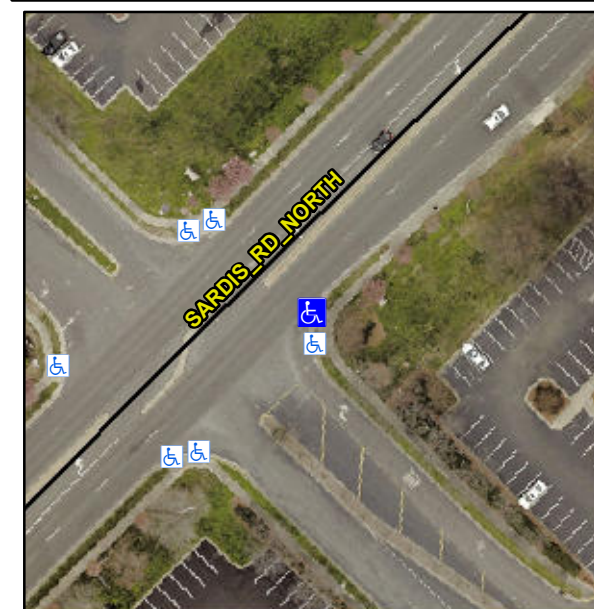
**Not Found, R304.2.2**

Compliance	Description	Data	Compliance	Description	Data
N/A	Ramp Length (in)	60.0	No	Ramp Slope (%)	9.8
Yes	Ramp Width (in)	48.0	Yes	Ramp XSlope (%)	0.4
N/A	Flare Type LT	N/A	N/A	Flare Type RT	N/A
N/A	Flare Slope LT (%)	N/A	N/A	Flare Slope RT (%)	N/A
N/A	Flare Traversable LT?	N/A	N/A	Flare Traversable RT?	N/A
N/A	Landing Length (in)	N/A	N/A	DWS Provided?	N/A
N/A	Landing Width (in)	N/A	N/A	DWS Contrast?	N/A
N/A	Landing Slope (%)	N/A	N/A	DWS Length (in)	N/A
N/A	Landing X Slope (%)	N/A	N/A	DWS Full Width?	N/A
N/A	Landing Curb? (Y/N)	N/A	N/A	DWS Offset (in)	N/A
N/A	Shared Landing?	N/A			
N/A	Gutter Ponding?	N/A	N/A	Gutter Slope (%)	N/A
N/A	Gutter Lip Ht (in)	N/A	N/A	Gutter X Slope (%)	N/A
N/A	Painted X Walk1?	No	N/A	Painted X Walk2?	N/A
	X Walk 1 Direction	To NW		X Walk 2 Direction	N/A
N/A	X Walk 1 Width (in)	N/A	N/A	X Walk 2 Width (in)	N/A
	X Walk 1 Slope (%)	0.4		X Walk 2 Slope (%)	N/A
	X Walk 1 X Slope (%)	0.8		X Walk 2 X Slope (%)	N/A

N/A	Ramp inside XWalk1?	N/A	N/A	Ramp inside XWalk2?	N/A
	Road Slope (%)	N/A	N/A	Clear Space?	N/A
	Road X Slope (%)	N/A	N/A	Clear Space to XWalk (in)	N/A
N/A	Any Obstructions?	N/A	N/A	Storm Grate/Utility Hazard?	N/A
	Obstruction Type			Storm Grate/Utility Type	
		N/A			N/A
			Yes	Surface Condition? (G/P)	Good

Possible Solutions:

**Remove & Replace Entire Ramp.**
