Access Compliance Report Public Rights-of-Way (Curb Ramps)

Intersection ID: 11456 Main Street: E_W_T_HARRIS_BV Cross Street: ROSECROFT_DR Location: SE

ADA ID: AB00BB9B008D Ramp Type: PerpDiag Initial Pass/Fail: Fail Overall Compliance: No Severity Score: 22.5

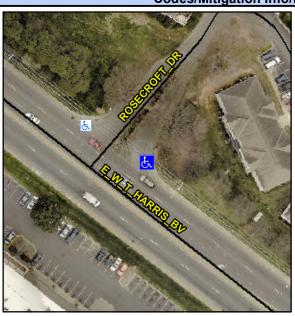
Not Found, R304.5.1, R304.2.2, R304.5.3

Compliance Description Data Compliance Description Data No N/A Ramp Length (in) 60.0 Ramp Slope (%) 11.4 No Ramp XSlope (%) No Ramp Width (in) 45.0 2.5 N/A N/A Flare Type LT N/A Flare Type RT N/A N/A N/A N/A Flare Slope RT (%) N/A Flare Slope LT (%) N/A Flare Traversable LT? N/A N/A Flare Traversable RT? N/A N/A N/A N/A DWS Provided? N/A Landing Length (in) N/A Landing Width (in) N/A N/A **DWS Contrast?** N/A N/A N/A Landing Slope (%) N/A DWS Length (in) N/A N/A Landing X Slope (%) N/A N/A DWS Full Width? N/A N/A Landing Curb? (Y/N) N/A N/A DWS Offset (in) N/A N/A N/A Shared Landing? N/A **Gutter Ponding?** N/A Gutter Slope (%) N/A Yes N/A Gutter Lip Ht (in) N/A N/A Gutter X Slope (%) N/A N/A Painted X Walk1? No N/A Painted X Walk2? No X Walk 1 Direction To NE X Walk 2 Direction To W N/A N/A X Walk 1 Width (in) X Walk 2 Width (in) N/A X Walk 1 Slope (%) 2.7 X Walk 2 Slope (%) 3.6 X Walk 1 X Slope (%) 1.9 X Walk 2 X Slope (%) 1.2 N/A N/A N/A Ramp inside XWalk2? N/A Ramp inside XWalk1? Road Slope (%) 1.0 N/A Clear Space? N/A N/A Road X Slope (%) Clear Space to XWalk (in) N/A 4.0 N/A N/A N/A Any Obstructions? Storm Grate/Utility Hazard? N/A **Obstruction Type** Storm Grate/Utility Type N/A N/A Yes Surface Condition? (G/P) Good

Remove & Replace Curb Ramp With Two New Directional Ramps or Equivalent.
