Access Compliance Report

Public Rights-of-Way

(Curb Ramps)

Intersection ID: 50704	Main Street: REUNION_ST	Cross Street: HARMONIOUS_ST	Location: E
ADA ID: AB09E38CC90B	Ramp Type: Perp	Initial Pass/Fail: Fail	Overall Compliance: No
Severity Score: 33.75			
Codes/Mitigation Info/Possible Solution		Field Measurements/Component Compliance

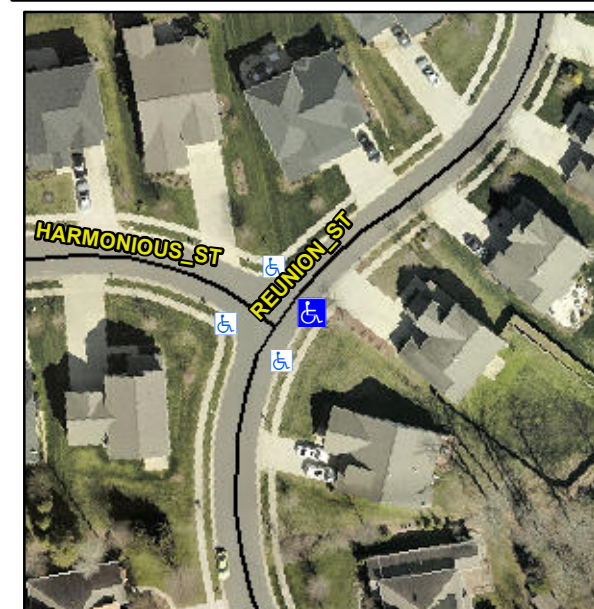
Not Found, R304.5.1, R304.2.2, R304.5.3

Compliance	Description	Data	Compliance	Description	Data
N/A	Ramp Length (in)	46.3	No	Ramp Slope (%)	8.8
No	Ramp Width (in)	47.0	No	Ramp XSlope (%)	5.7
N/A	Flare Type LT	N/A	N/A	Flare Type RT	N/A
N/A	Flare Slope LT (%)	N/A	N/A	Flare Slope RT (%)	N/A
N/A	Flare Traversable LT?	N/A	N/A	Flare Traversable RT?	N/A
N/A	Landing Length (in)	N/A	N/A	DWS Provided?	N/A
N/A	Landing Width (in)	N/A	N/A	DWS Contrast?	N/A
N/A	Landing Slope (%)	N/A	N/A	DWS Length (in)	N/A
N/A	Landing X Slope (%)	N/A	N/A	DWS Full Width?	N/A
N/A	Landing Curb? (Y/N)	N/A	N/A	DWS Offset (in)	N/A
N/A	Shared Landing?	N/A			
N/A	Gutter Ponding?	N/A	N/A	Gutter Slope (%)	N/A
N/A	Gutter Lip Ht (in)	N/A	N/A	Gutter X Slope (%)	N/A
N/A	Painted X Walk1?	No	N/A	Painted X Walk2?	N/A
	X Walk 1 Direction	To NW		X Walk 2 Direction	N/A
N/A	X Walk 1 Width (in)	N/A	N/A	X Walk 2 Width (in)	N/A
	X Walk 1 Slope (%)	0.7		X Walk 2 Slope (%)	N/A
	X Walk 1 X Slope (%)	7.1		X Walk 2 X Slope (%)	N/A

Possible Solutions:

Remove & Replace Entire Ramp.

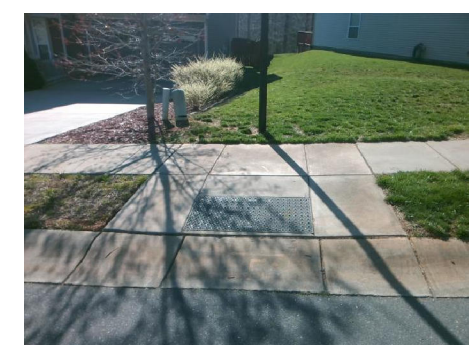
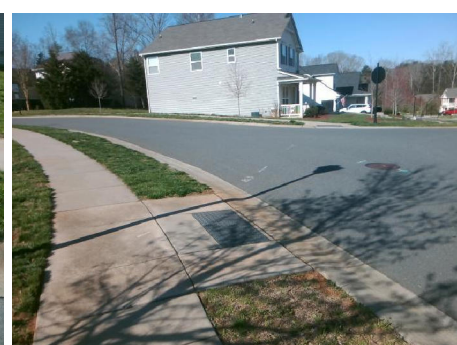
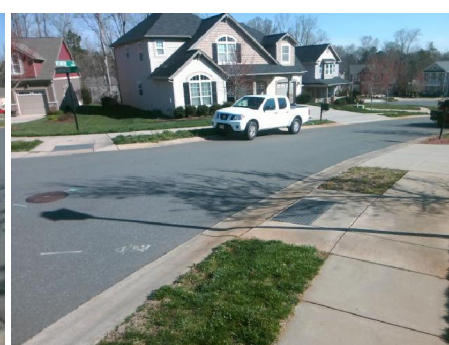
N/A	Ramp inside XWalk1?	N/A	N/A	Ramp inside XWalk2?	N/A
	Road Slope (%)	N/A	N/A	Clear Space?	N/A
	Road X Slope (%)	N/A	N/A	Clear Space to XWalk (in)	N/A
N/A	Any Obstructions?	N/A	N/A	Storm Grate/Utility Hazard?	N/A
	Obstruction Type			Storm Grate/Utility Type	
		N/A			N/A
			Yes	Surface Condition? (G/P)	Good
