Access Compliance Report Public Rights-of-Way (Curb Ramps)

Intersection ID: N/A Main Street: COSTIGAN LN **Cross Street: DURANT BV** Location: **Overall Compliance: No** ADA ID: AB0BADD962C3 Ramp Type: PerpDiag Initial Pass/Fail: Fail Severity Score: 21.25

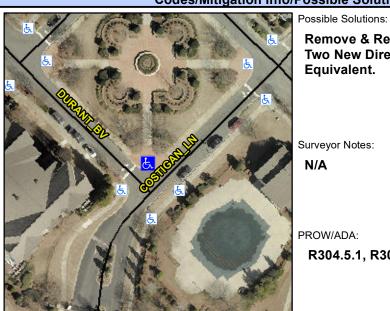
Compliance Description			Data	Compliance Description			Data
			Data				Data
N/A	Ram	Length (in)	81.0	No	Ramp	o Slope (%)	9.1
No	No Ramp Width (in)		46.0	Yes	Ramp	XSlope (%)	0.6
N/A	Flare	Type LT	N/A	N/A	Flare	Type RT	N/A
N/A	Flare	Slope LT (%)	N/A	N/A	Flare	Slope RT (%)	N/A
N/A	Flare	Traversable LT?	N/A	N/A	Flare	Traversable RT?	N/A
N/A	Land	ing Length (in)	N/A	N/A	DWS	Provided?	N/A
N/A	Land	ing Width (in)	N/A	N/A	DWS	Contrast?	N/A
N/A	Land	ing Slope (%)	N/A	N/A	DWS	Length (in)	N/A
N/A	Land	ing X Slope (%)	N/A	N/A	DWS	Full Width?	N/A
N/A	Land	ing Curb? (Y/N)	N/A	N/A	DWS	Offset (in)	N/A
N/A	Share	ed Landing?	N/A				
N/A	Gutte	er Ponding?	N/A	N/A	Gutte	er Slope (%)	N/A
N/A	Gutte	er Lip Ht (in)	N/A	N/A	Gutte	er X Slope (%)	N/A
N/A	Paint	ed X Walk1?	No	N/A	Paint	ed X Walk2?	No
	X Wa	lk 1 Direction	To SW		X Wa	lk 2 Direction	To SE
N/A	X Wa	ılk 1 Width (in)	N/A	N/A	X Wa	lk 2 Width (in)	N/A
	X Wa	ılk 1 Slope (%)	2.1		X Wa	lk 2 Slope (%)	0.9

X Wa	ılk 1 X Slope (%)	1.1		X Wa	lk 2 X Slope (%)	0.2
N/A	Ram	p inside XWalk1?	N/A	N/A	Ram	o inside XWalk2?	N/A
	Road	Slope (%)	0.8	N/A	Clear	Space?	N/A
	Road	I X Slope (%)	0.7	N/A	Clear	Space to XWalk (in)	N/A
N/A	Any (Obstructions?	N/A	N/A	Storn	n Grate/Utility Hazard?	N/A
	Obst	ruction Type		l	Storn	n Grate/Utility Type	
			N/A	l			N/A

Remove & Replace Curb Ramp With Two New Directional Ramps or Equivalent.

R304.5.1, R304.2.2

Total Cost: 3200.00
