Access Compliance Report

Public Rights-of-Way

(Curb Ramps)

Intersection ID: 30455	Main Street: HARMONY_GLEN_CT	Cross Street: WALLAND_LN	Location: NE
ADA ID: AB0E6BDDD7AE	Ramp Type: PerpDiag	Initial Pass/Fail: Fail	Overall Compliance: No
Severity Score: 13.75			
Codes/Mitigation Info/Possible Solution		Field Measurements/Component Compliance

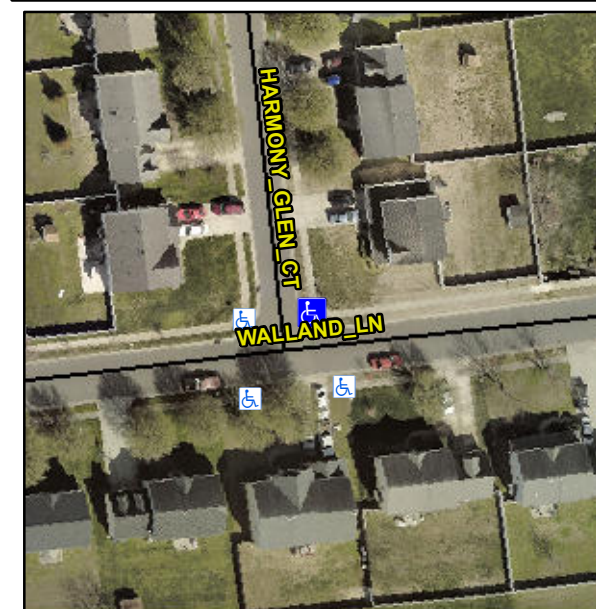
R304.2.2, R304.5.3

Compliance	Description	Data	Compliance	Description	Data
N/A	Ramp Length (in)	46.0	No	Ramp Slope (%)	8.6
Yes	Ramp Width (in)	48.0	No	Ramp XSlope (%)	3.3
N/A	Flare Type LT	N/A	N/A	Flare Type RT	N/A
N/A	Flare Slope LT (%)	N/A	N/A	Flare Slope RT (%)	N/A
N/A	Flare Traversable LT?	N/A	N/A	Flare Traversable RT?	N/A
N/A	Landing Length (in)	N/A	N/A	DWS Provided?	N/A
N/A	Landing Width (in)	N/A	N/A	DWS Contrast?	N/A
N/A	Landing Slope (%)	N/A	N/A	DWS Length (in)	N/A
N/A	Landing X Slope (%)	N/A	N/A	DWS Full Width?	N/A
N/A	Landing Curb? (Y/N)	N/A	N/A	DWS Offset (in)	N/A
N/A	Shared Landing?	N/A			
N/A	Gutter Ponding?	N/A	N/A	Gutter Slope (%)	N/A
N/A	Gutter Lip Ht (in)	N/A	N/A	Gutter X Slope (%)	N/A
N/A	Painted X Walk1?	No	N/A	Painted X Walk2?	No
	X Walk 1 Direction	To W		X Walk 2 Direction	To S
N/A	X Walk 1 Width (in)	N/A	N/A	X Walk 2 Width (in)	N/A
	X Walk 1 Slope (%)	0.8		X Walk 2 Slope (%)	2.2
	X Walk 1 X Slope (%)	1.2		X Walk 2 X Slope (%)	0.5

N/A	Ramp inside XWalk1?	N/A	N/A	Ramp inside XWalk2?	N/A
	Road Slope (%)	0.3	N/A	Clear Space?	N/A
	Road X Slope (%)	3.9	N/A	Clear Space to XWalk (in)	N/A
N/A	Any Obstructions?	N/A	N/A	Storm Grate/Utility Hazard?	N/A
	Obstruction Type			Storm Grate/Utility Type	
		N/A			N/A
		Yes		Surface Condition? (G/P)	Good

Possible Solutions:

Remove & Replace Curb Ramp With Two New Directional Ramps or Equivalent.

Total Cost: \$ 3200.00
