# Access Compliance Report

## Public Rights-of-Way

### (Curb Ramps)

Intersection ID: 3053	Main Street: WHITE_STAG_DR	Cross Street: WHITETAIL_CT	Location: NW
ADA ID: AB25AAC2C715	Ramp Type: Perp	Initial Pass/Fail: Fail	Overall Compliance: No
Severity Score: 8.75			
Codes/Mitigation Info/Possible Solution		Field Measurements/Component Compliance

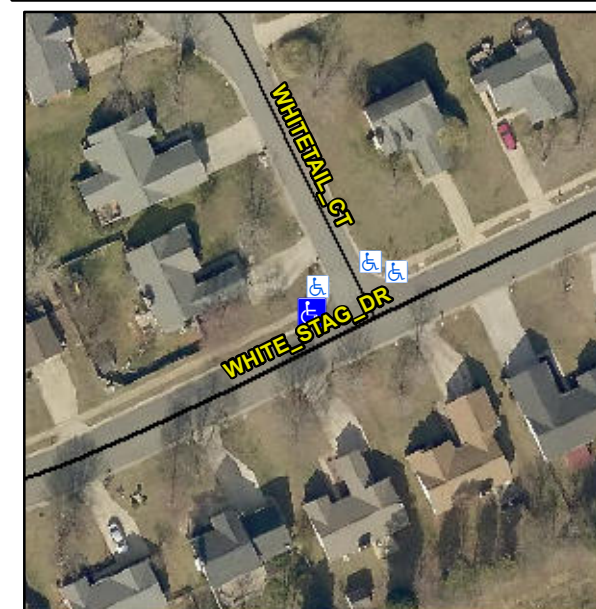
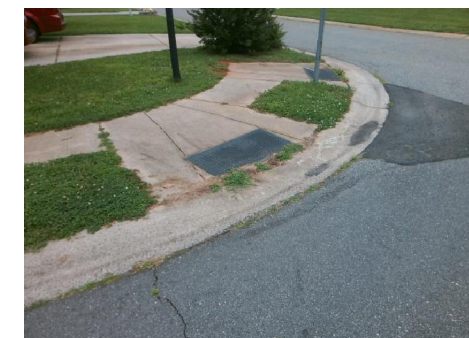
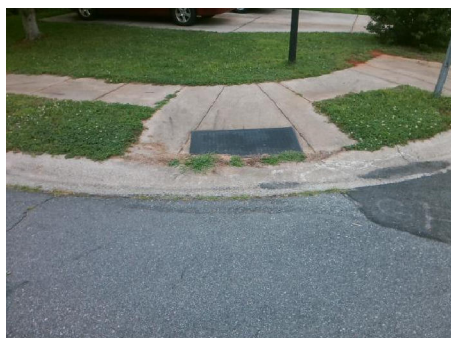
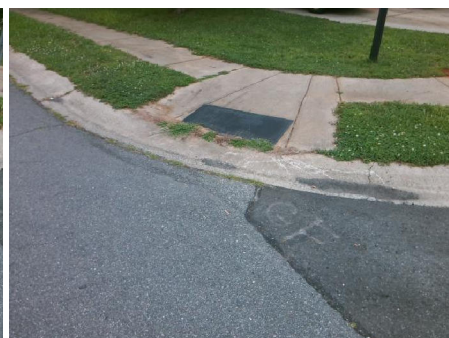
Compliance	Description	Data	Compliance	Description	Data
N/A	Ramp Length (in)	48.0	Yes	Ramp Slope (%)	8.1
No	Ramp Width (in)	36.0	Yes	Ramp XSlope (%)	2.0
N/A	Flare Type LT	N/A	N/A	Flare Type RT	N/A
N/A	Flare Slope LT (%)	N/A	N/A	Flare Slope RT (%)	N/A
N/A	Flare Traversable LT?	N/A	N/A	Flare Traversable RT?	N/A
N/A	Landing Length (in)	N/A	N/A	DWS Provided?	N/A
N/A	Landing Width (in)	N/A	N/A	DWS Contrast?	N/A
N/A	Landing Slope (%)	N/A	N/A	DWS Length (in)	N/A
N/A	Landing X Slope (%)	N/A	N/A	DWS Full Width?	N/A
N/A	Landing Curb? (Y/N)	N/A	N/A	DWS Offset (in)	N/A
N/A	Shared Landing?	N/A			
N/A	Gutter Ponding?	N/A	N/A	Gutter Slope (%)	N/A
N/A	Gutter Lip Ht (in)	N/A	N/A	Gutter X Slope (%)	N/A
N/A	Painted X Walk1?	No	N/A	Painted X Walk2?	N/A
	X Walk 1 Direction	To S		X Walk 2 Direction	N/A
N/A	X Walk 1 Width (in)	N/A	N/A	X Walk 2 Width (in)	N/A
	X Walk 1 Slope (%)	6.6		X Walk 2 Slope (%)	N/A
	X Walk 1 X Slope (%)	1.1		X Walk 2 X Slope (%)	N/A

N/A	Ramp inside XWalk1?	N/A	N/A	Ramp inside XWalk2?	N/A
	Road Slope (%)	N/A	N/A	Clear Space?	N/A
	Road X Slope (%)	N/A	N/A	Clear Space to XWalk (in)	N/A
N/A	Any Obstructions?	N/A	N/A	Storm Grate/Utility Hazard?	N/A
	Obstruction Type			Storm Grate/Utility Type	
		N/A			N/A
			Yes	Surface Condition? (G/P)	Good

**Remove & Replace Entire Ramp.**
