# Access Compliance Report

## Public Rights-of-Way

### (Curb Ramps)

Intersection ID: 5273	Main Street: GROVE_LAKE_DR	Cross Street: GROVE_CREST_LN	Location: E
ADA ID: AB2CB1B84F9F	Ramp Type: PerpDiag	Initial Pass/Fail: Fail	Overall Compliance: No
Severity Score: 58.75			
Codes/Mitigation Info/Possible Solution		Field Measurements/Component Compliance

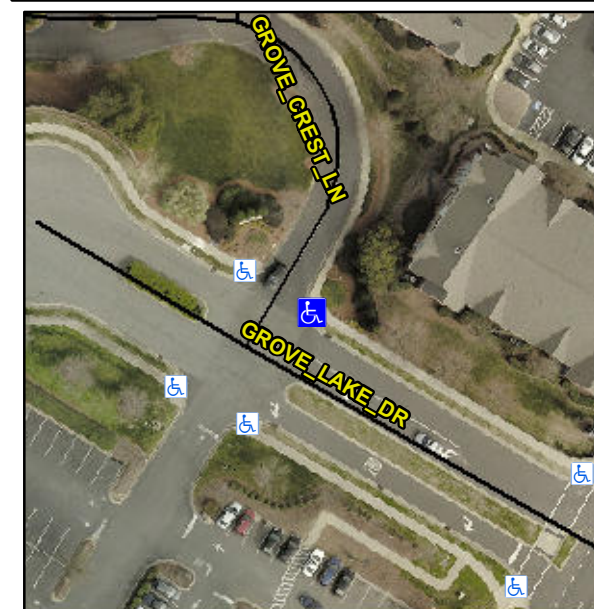
Compliance	Description	Data	Compliance	Description	Data
N/A	Ramp Length (in)	79.0	No	Ramp Slope (%)	14.6
No	Ramp Width (in)	37.0	No	Ramp XSlope (%)	8.2
N/A	Flare Type LT	N/A	N/A	Flare Type RT	N/A
N/A	Flare Slope LT (%)	N/A	N/A	Flare Slope RT (%)	N/A
N/A	Flare Traversable LT?	N/A	N/A	Flare Traversable RT?	N/A
N/A	Landing Length (in)	N/A	N/A	DWS Provided?	N/A
N/A	Landing Width (in)	N/A	N/A	DWS Contrast?	N/A
N/A	Landing Slope (%)	N/A	N/A	DWS Length (in)	N/A
N/A	Landing X Slope (%)	N/A	N/A	DWS Full Width?	N/A
N/A	Landing Curb? (Y/N)	N/A	N/A	DWS Offset (in)	N/A
N/A	Shared Landing?	N/A			
N/A	Gutter Ponding?	N/A	N/A	Gutter Slope (%)	N/A
N/A	Gutter Lip Ht (in)	N/A	N/A	Gutter X Slope (%)	N/A
N/A	Painted X Walk1?	No	N/A	Painted X Walk2?	No
	X Walk 1 Direction	To NW		X Walk 2 Direction	To SW
N/A	X Walk 1 Width (in)	N/A	N/A	X Walk 2 Width (in)	N/A
	X Walk 1 Slope (%)	0.6		X Walk 2 Slope (%)	1.8
	X Walk 1 X Slope (%)	6.1		X Walk 2 X Slope (%)	1.2

N/A	Ramp inside XWalk1?	N/A	N/A	Ramp inside XWalk2?	N/A
	Road Slope (%)	1.9	N/A	Clear Space?	N/A
	Road X Slope (%)	2.6	N/A	Clear Space to XWalk (in)	N/A
N/A	Any Obstructions?	N/A	N/A	Storm Grate/Utility Hazard?	N/A
	Obstruction Type			Storm Grate/Utility Type	
		N/A			N/A
			Yes	Surface Condition? (G/P)	Good

**Remove & Replace Curb Ramp With Two New Directional Ramps or Equivalent.**
