# Access Compliance Report

## Public Rights-of-Way

| Intersection ID: 13871 | Main Street: E_5TH_ST | Cross Street: HAWTHORNE_LN | Location: W |
| ADA ID: AB3715A260EC | Ramp Type: BlendTrans1 | Initial Pass/Fail: Pass | Overall Compliance: No |

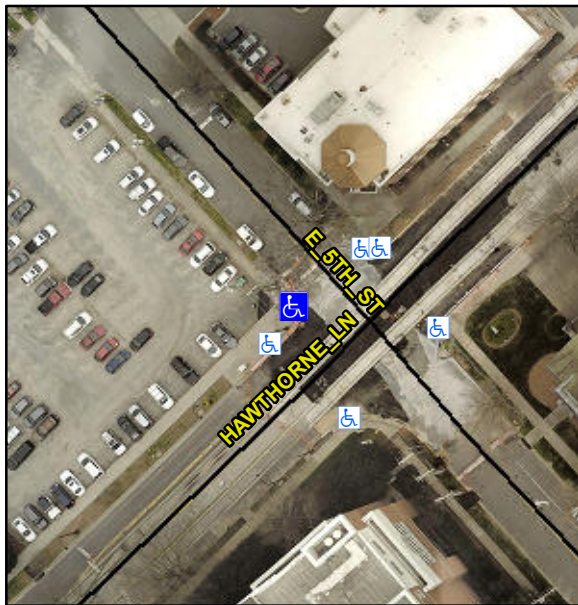
**Not Found, R304.5.3**

| Compliance | Description | Data | Compliance | Description | Data |
|---|---|---|---|---|---|
| Yes | Gutter Lip Ht (in) | 0.0 | No | Gutter X Slope (%) | 3.2 |
| | | | No | Curb Slope (%) | 16.4 |

**Remove & Replace Curb Slope and Extend Ramp. Remove & Replace Gutter.**
