Access Compliance Report

Public Rights-of-Way

(Curb Ramps)

Intersection ID: 30146	Main Street: HEMBY_WOODS_DR	Cross Street: RAIN_CREEK_WY	Location: SE
ADA ID: AB3EA0597C2E	Ramp Type: Perp	Initial Pass/Fail: Fail	Overall Compliance: No
Severity Score: 10			
Codes/Mitigation Info/Possible Solution		Field Measurements/Component Compliance

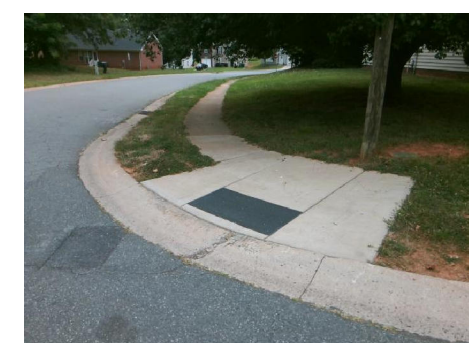
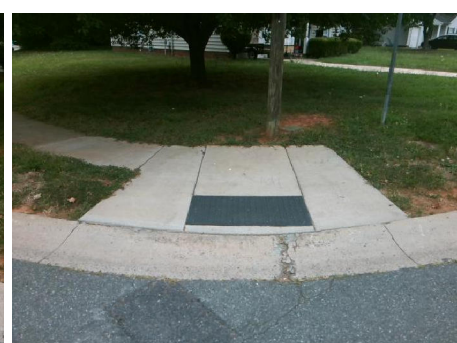
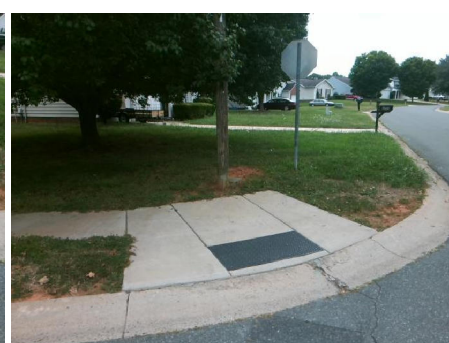
Compliance	Description	Data	Compliance	Description	Data
N/A	Ramp Length (in)	97.0	Yes	Ramp Slope (%)	6.6
No	Ramp Width (in)	46.5	No	Ramp XSlope (%)	2.8
N/A	Flare Type LT	N/A	N/A	Flare Type RT	N/A
N/A	Flare Slope LT (%)	N/A	N/A	Flare Slope RT (%)	N/A
N/A	Flare Traversable LT?	N/A	N/A	Flare Traversable RT?	N/A
N/A	Landing Length (in)	N/A	N/A	DWS Provided?	N/A
N/A	Landing Width (in)	N/A	N/A	DWS Contrast?	N/A
N/A	Landing Slope (%)	N/A	N/A	DWS Length (in)	N/A
N/A	Landing X Slope (%)	N/A	N/A	DWS Full Width?	N/A
N/A	Landing Curb? (Y/N)	N/A	N/A	DWS Offset (in)	N/A
N/A	Shared Landing?	N/A			
N/A	Gutter Ponding?	N/A	N/A	Gutter Slope (%)	N/A
N/A	Gutter Lip Ht (in)	N/A	N/A	Gutter X Slope (%)	N/A
N/A	Painted X Walk1?	No	N/A	Painted X Walk2?	N/A
	X Walk 1 Direction	To W		X Walk 2 Direction	N/A
N/A	X Walk 1 Width (in)	N/A	N/A	X Walk 2 Width (in)	N/A
	X Walk 1 Slope (%)	3.8		X Walk 2 Slope (%)	N/A
	X Walk 1 X Slope (%)	0.7		X Walk 2 X Slope (%)	N/A

N/A	Ramp inside XWalk1?	N/A	N/A	Ramp inside XWalk2?	N/A
	Road Slope (%)	N/A	N/A	Clear Space?	N/A
	Road X Slope (%)	N/A	N/A	Clear Space to XWalk (in)	N/A
N/A	Any Obstructions?	N/A	N/A	Storm Grate/Utility Hazard?	N/A
	Obstruction Type			Storm Grate/Utility Type	
		N/A			N/A
			Yes	Surface Condition? (G/P)	Good

Possible Solutions:

Remove & Replace Entire Ramp.
