# Access Compliance Report

## Public Rights-of-Way

### (Curb Ramps)

Intersection ID: 11360	Main Street: GRACE_ST	Cross Street: SEIGLE_AV	Location: S
ADA ID: AB42EAFF23E2	Ramp Type: Directional1	Initial Pass/Fail: Fail	Overall Compliance: No
		Severity Score: 37.5	
Codes/Mitigation Info/Possible Solution		Field Measurements/Component Compliance

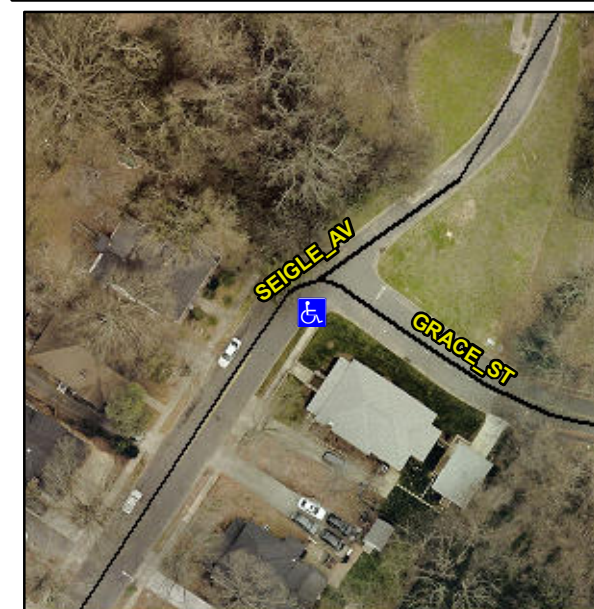
Compliance	Description	Data	Compliance	Description	Data
N/A	Ramp Length (in)	32.0	N/A	Grade Break?	N/A
Yes	Ramp Width (in)	66.0	N/A	Grade Break Slope (%)	0.0
No	Ramp Slope (%)	10.0	N/A	Grade Break XSlope (%)	0.0
No	Ramp XSlope (%)	8.2			
N/A	Flare Type LT	N/A	N/A	Flare Type RT	N/A
N/A	Flare Slope LT (%)	N/A	N/A	Flare Slope RT (%)	0.0
N/A	Flare Traversable LT?	N/A	N/A	Flare Traversable RT?	N/A
N/A	Landing Length (in)	0.0	N/A	DWS Provided?	N/A
N/A	Landing Width (in)	0.0	N/A	DWS Contrast?	N/A
N/A	Landing Slope (%)	0.0	N/A	DWS Length (in)	N/A
N/A	Landing X Slope (%)	0.0	N/A	DWS Full Width?	N/A
N/A	Landing Curb? (Y/N)	N/A	N/A	DWS Offset LT (in)	N/A
N/A	Shared Landing?	N/A	N/A	DWS Offset RT (in)	N/A
N/A	Gutter Ponding?	0.0	N/A	Gutter Slope (%)	N/A
N/A	Gutter Lip Ht (in)	0.0	N/A	Gutter X Slope (%)	N/A
N/A	Painted X Walk1?	No		Road Slope (%)	2.8
	X Walk 1 Direction	To NW		Road X Slope (%)	4.4
	X Walk 1 Width (in)	N/A		Clear Space?	N/A

X Walk 1 Slope (%)	2.8	N/A	Clear Space to XWalk (in)	N/A
	X Walk 1 X Slope (%)	4.4	N/A	Storm Grate/Utility Hazard?	N/A
N/A	Ramp inside XWalk1?	N/A		Storm Grate/Utility Type	
N/A	Any Obstructions?	N/A			N/A
	Obstruction Type		Yes	Surface Condition? (G/P)	Good
			N/A	Curb Slope (%)	10.1

Possible Solutions:

**Remove & Replace Entire Ramp.**
