# Access Compliance Report

## Public Rights-of-Way

### (Curb Ramps)

Intersection ID: 23951	Main Street: S_TRYON_ST	Cross Street: CHOATE_CR	Location: NE
ADA ID: AB45222B9650	Ramp Type: Perp	Initial Pass/Fail: Fail	Overall Compliance: No
		Severity Score: 12.5

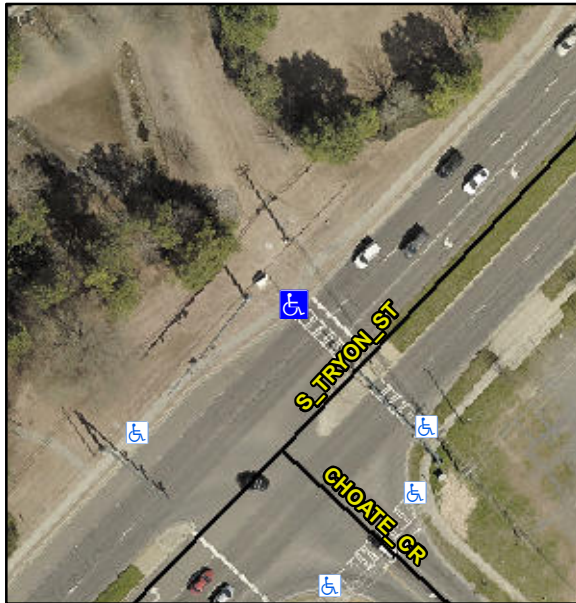
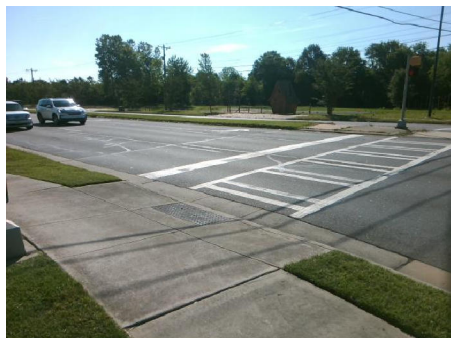
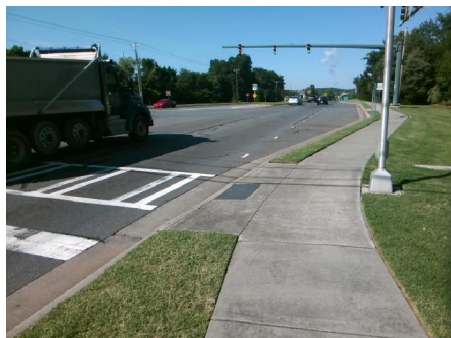
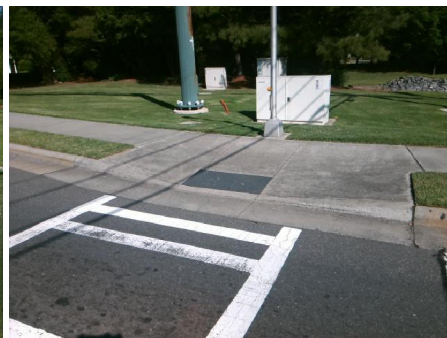
**Not Found, R304.2.2**

Compliance	Description	Data	Compliance	Description	Data
N/A	Ramp Length (in)	98.0	No	Ramp Slope (%)	8.5
Yes	Ramp Width (in)	48.0	Yes	Ramp XSlope (%)	0.7
N/A	Flare Type LT	N/A	N/A	Flare Type RT	N/A
N/A	Flare Slope LT (%)	N/A	N/A	Flare Slope RT (%)	N/A
N/A	Flare Traversable LT?	N/A	N/A	Flare Traversable RT?	N/A
N/A	Landing Length (in)	N/A	N/A	DWS Provided?	N/A
N/A	Landing Width (in)	N/A	N/A	DWS Contrast?	N/A
N/A	Landing Slope (%)	N/A	N/A	DWS Length (in)	N/A
N/A	Landing X Slope (%)	N/A	N/A	DWS Full Width?	N/A
N/A	Landing Curb? (Y/N)	N/A	N/A	DWS Offset (in)	N/A
N/A	Shared Landing?	N/A			
N/A	Gutter Ponding?	N/A	N/A	Gutter Slope (%)	N/A
N/A	Gutter Lip Ht (in)	N/A	N/A	Gutter X Slope (%)	N/A
N/A	Painted X Walk1?	Yes	N/A	Painted X Walk2?	N/A
	X Walk 1 Direction	To SE		X Walk 2 Direction	N/A
N/A	X Walk 1 Width (in)	99.0	N/A	X Walk 2 Width (in)	N/A
	X Walk 1 Slope (%)	3.3		X Walk 2 Slope (%)	N/A
	X Walk 1 X Slope (%)	0.1		X Walk 2 X Slope (%)	N/A

N/A	Ramp inside XWalk1?	Yes	N/A	Ramp inside XWalk2?	N/A
	Road Slope (%)	N/A	N/A	Clear Space?	N/A
	Road X Slope (%)	N/A	N/A	Clear Space to XWalk (in)	N/A
N/A	Any Obstructions?	N/A	N/A	Storm Grate/Utility Hazard?	N/A
	Obstruction Type			Storm Grate/Utility Type	
		N/A			N/A
			Yes	Surface Condition? (G/P)	Good

Possible Solutions:

**Remove & Replace Entire Ramp.**
