# Access Compliance Report

## Public Rights-of-Way

### (Curb Ramps)

Intersection ID: 43751	Main Street: POTTERS_GLEN_RD	Cross Street: RAKU_CT	Location: SE
ADA ID: AB4AEBECBA87	Ramp Type: Perp	Initial Pass/Fail: Fail	Overall Compliance: No
Severity Score: 33.75			
Codes/Mitigation Info/Possible Solution		Field Measurements/Component Compliance

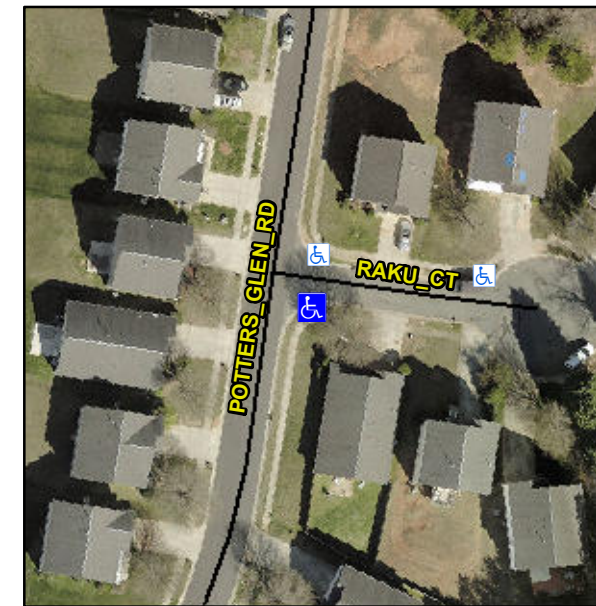
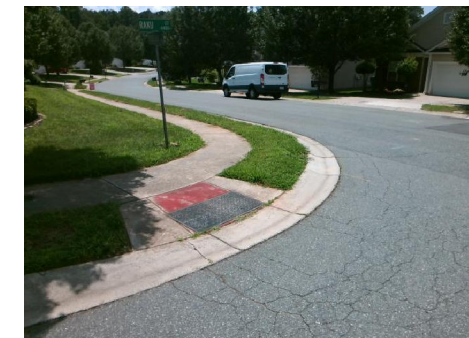
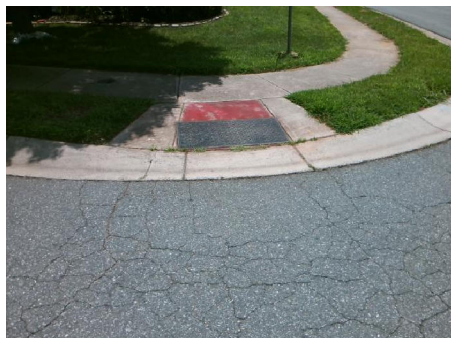
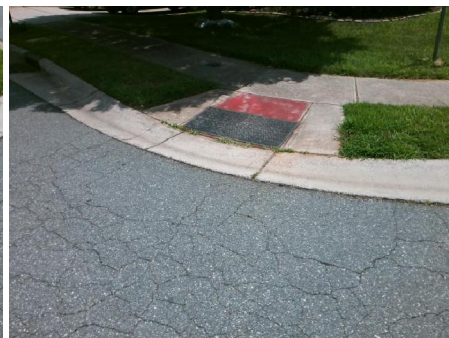
Compliance	Description	Data	Compliance	Description	Data
N/A	Ramp Length (in)	47.5	No	Ramp Slope (%)	9.1
No	Ramp Width (in)	40.5	No	Ramp XSlope (%)	5.4
N/A	Flare Type LT	N/A	N/A	Flare Type RT	N/A
N/A	Flare Slope LT (%)	N/A	N/A	Flare Slope RT (%)	N/A
N/A	Flare Traversable LT?	N/A	N/A	Flare Traversable RT?	N/A
N/A	Landing Length (in)	N/A	N/A	DWS Provided?	N/A
N/A	Landing Width (in)	N/A	N/A	DWS Contrast?	N/A
N/A	Landing Slope (%)	N/A	N/A	DWS Length (in)	N/A
N/A	Landing X Slope (%)	N/A	N/A	DWS Full Width?	N/A
N/A	Landing Curb? (Y/N)	N/A	N/A	DWS Offset (in)	N/A
N/A	Shared Landing?	N/A			
N/A	Gutter Ponding?	N/A	N/A	Gutter Slope (%)	N/A
N/A	Gutter Lip Ht (in)	N/A	N/A	Gutter X Slope (%)	N/A
N/A	Painted X Walk1?	No	N/A	Painted X Walk2?	N/A
	X Walk 1 Direction	To N		X Walk 2 Direction	N/A
N/A	X Walk 1 Width (in)	N/A	N/A	X Walk 2 Width (in)	N/A
	X Walk 1 Slope (%)	3.3		X Walk 2 Slope (%)	N/A
	X Walk 1 X Slope (%)	3.8		X Walk 2 X Slope (%)	N/A

N/A	Ramp inside XWalk1?	N/A	N/A	Ramp inside XWalk2?	N/A
	Road Slope (%)	N/A	N/A	Clear Space?	N/A
	Road X Slope (%)	N/A	N/A	Clear Space to XWalk (in)	N/A
N/A	Any Obstructions?	N/A	N/A	Storm Grate/Utility Hazard?	N/A
	Obstruction Type			Storm Grate/Utility Type	
		N/A			N/A
			Yes	Surface Condition? (G/P)	Good

**Remove & Replace Entire Ramp.**

**R304.5.1, R304.2.2, R304.5.3**
