# Access Compliance Report

## Public Rights-of-Way

### (Curb Ramps)

| Intersection ID: N/A | Main Street: CITY_PARK_DR | Cross Street: TYVOLA_RD | Location: E |

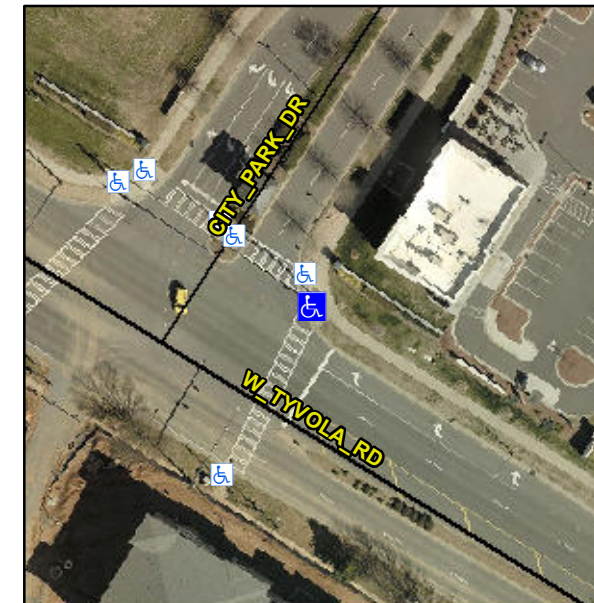
**R304.5.3, R305.2**

| Compliance | Description | Data | Compliance | Description | Data |
|---|---|---|---|---|---|
| Yes | Ramp Width (in) | 48.0 | No | Ramp XSlope (%) | 4.6 |
| No | Landing X Slope (%) | 5.7 | Yes | DWS Full Width? | Yes |
| N/A | Landing Curb? (Y/N) | No | No | DWS Offset (in) | 4.0 |
| Yes | Gutter Lip Ht (in) | 0.0 | No | Gutter X Slope (%) | 3.7 |

**Remove & Replace Entire Ramp.  
Remove & Replace Gutter.**
