# Access Compliance Report

## Public Rights-of-Way

### (Curb Ramps)

Intersection ID: N/A	Main Street: TRYON_ST	Cross Street: PUMPERNICKEL_RD	Location: SE
ADA ID: AB5CAE3D87E8	Ramp Type: PerpDiag	Initial Pass/Fail: Fail	Overall Compliance: No
Severity Score: 13.75			
Codes/Mitigation Info/Possible Solution		Field Measurements/Component Compliance

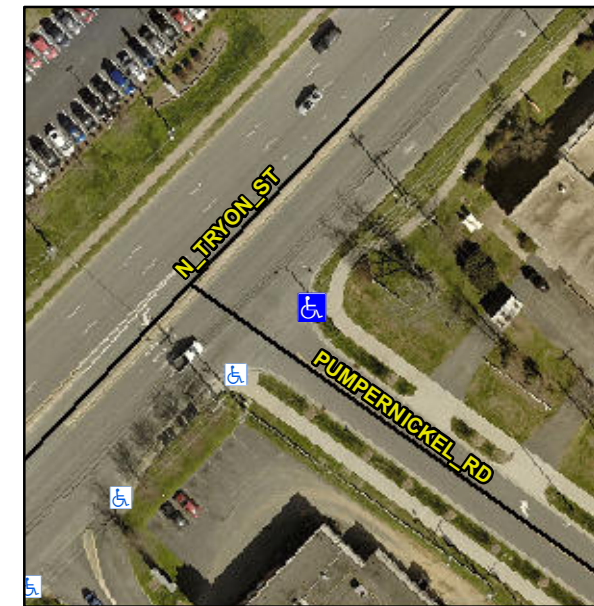
**R304.2.2, R304.5.3**

Compliance	Description	Data	Compliance	Description	Data
N/A	Ramp Length (in)	98.0	No	Ramp Slope (%)	9.3
Yes	Ramp Width (in)	49.0	No	Ramp XSlope (%)	2.1
N/A	Flare Type LT	N/A	N/A	Flare Type RT	N/A
N/A	Flare Slope LT (%)	N/A	N/A	Flare Slope RT (%)	N/A
N/A	Flare Traversable LT?	N/A	N/A	Flare Traversable RT?	N/A
N/A	Landing Length (in)	N/A	N/A	DWS Provided?	N/A
N/A	Landing Width (in)	N/A	N/A	DWS Contrast?	N/A
N/A	Landing Slope (%)	N/A	N/A	DWS Length (in)	N/A
N/A	Landing X Slope (%)	N/A	N/A	DWS Full Width?	N/A
N/A	Landing Curb? (Y/N)	N/A	N/A	DWS Offset (in)	N/A
N/A	Shared Landing?	N/A			
N/A	Gutter Ponding?	N/A	N/A	Gutter Slope (%)	N/A
N/A	Gutter Lip Ht (in)	N/A	N/A	Gutter X Slope (%)	N/A
N/A	Painted X Walk1?	No	N/A	Painted X Walk2?	No
	X Walk 1 Direction	To N		X Walk 2 Direction	To W
N/A	X Walk 1 Width (in)	N/A	N/A	X Walk 2 Width (in)	N/A
	X Walk 1 Slope (%)	2.1		X Walk 2 Slope (%)	0.4
	X Walk 1 X Slope (%)	0.6		X Walk 2 X Slope (%)	0.3

N/A	Ramp inside XWalk1?	N/A	N/A	Ramp inside XWalk2?	N/A
	Road Slope (%)	1.6	N/A	Clear Space?	N/A
	Road X Slope (%)	1.7	N/A	Clear Space to XWalk (in)	N/A
N/A	Any Obstructions?	N/A	N/A	Storm Grate/Utility Hazard?	N/A
	Obstruction Type			Storm Grate/Utility Type	
		N/A			N/A
		Yes		Surface Condition? (G/P)	Good

Possible Solutions:

**Remove & Replace Curb Ramp With Two New Directional Ramps or Equivalent.**

Total Cost: \$ 3200.00
