# Access Compliance Report

## Public Rights-of-Way

### (Curb Ramps)

Intersection ID: 14949	Main Street: CAMPBELL_DR	Cross Street: DRIFTWOOD_DR	Location: NE
ADA ID: AB64BF309EF5	Ramp Type: BlendTrans1	Initial Pass/Fail: Fail	Overall Compliance: No
		Severity Score: 25

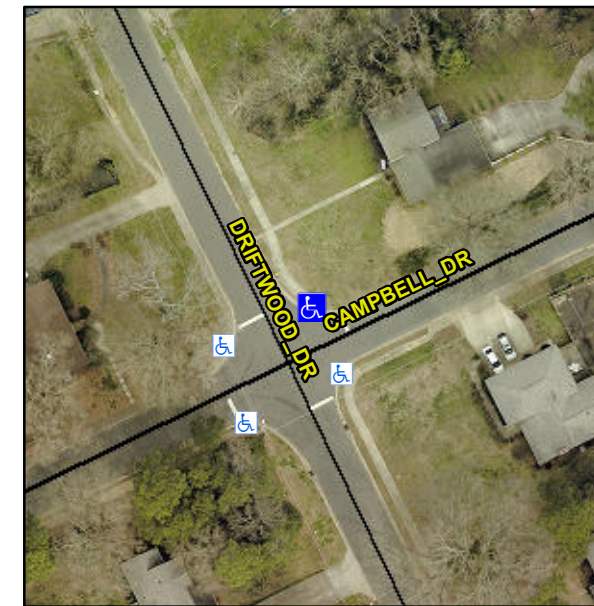
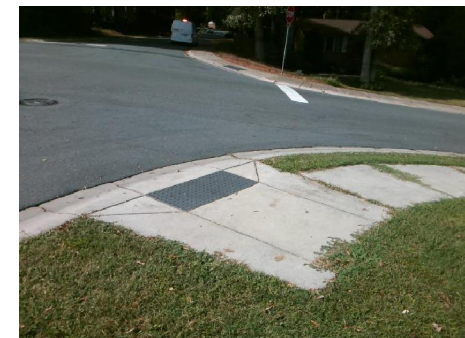
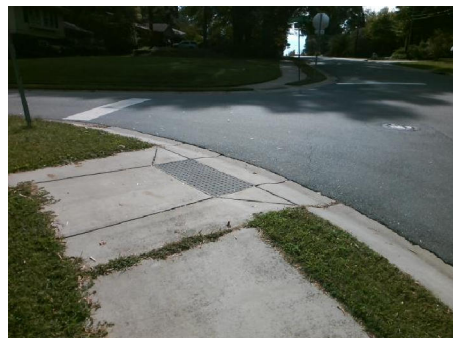
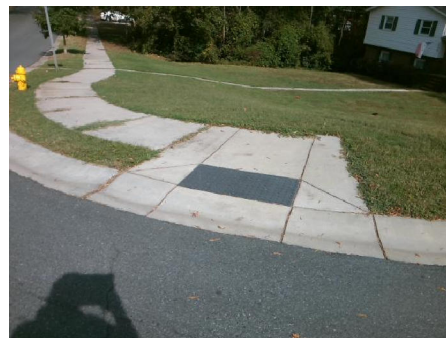
**Not Found, R304.5.3**

Compliance	Description	Data	Compliance	Description	Data
N/A	Ramp Length (in)	85.0	Yes	BlendTrans Slope (%)	4.0
Yes	Ramp Width (in)	48.0	No	BlendTrans XSlope (%)	10.7
N/A	Flare Type LT	N/A	N/A	Flare Type RT	N/A
N/A	Flare Slope LT (%)	N/A	N/A	Flare Slope RT (%)	N/A
N/A	Flare Traversable LT?	N/A	N/A	Flare Traversable RT?	N/A
N/A	Landing Length (in)	N/A	N/A	DWS Provided?	N/A
N/A	Landing Width (in)	N/A	N/A	DWS Contrast?	N/A
N/A	Landing Slope (%)	N/A	N/A	DWS Length (in)	N/A
N/A	Landing X Slope (%)	N/A	N/A	DWS Full Width?	N/A
N/A	Landing Curb? (Y/N)	N/A	N/A	DWS Offset (in)	N/A
N/A	Shared Landing?	N/A			
N/A	Gutter Ponding?	N/A	N/A	Gutter Slope (%)	N/A
N/A	Gutter Lip Ht (in)	N/A	N/A	Gutter X Slope (%)	N/A
N/A	Painted X Walk1?	No	N/A	Painted X Walk2?	No
	X Walk 1 Direction	To SW		X Walk 2 Direction	To SE
	X Walk 1 Width (in)	N/A		X Walk 2 Width (in)	N/A
	X Walk 1 Slope (%)	2.3		X Walk 2 Slope (%)	8.8
	X Walk 1 X Slope (%)	11.2		X Walk 2 X Slope (%)	0.6

N/A	Ramp inside XWalk1?	N/A	N/A	Ramp inside XWalk2?	N/A
	Road Slope (%)	8.0		Clear Space?	N/A
	Road X Slope (%)	9.6	N/A	Clear Space to XWalk (in)	N/A
N/A	Any Obstructions?	N/A	N/A	Storm Grate/Utility Hazard?	N/A
	Obstruction Type			Storm Grate/Utility Type	
		N/A			N/A
			Yes	Surface Condition? (G/P)	Good
			No	Curb Slope (%)	9.2

**Remove & Replace Curb Ramp With Two New Directional Ramps or Equivalent.**

Total Cost: \$ 3200.00
