# Access Compliance Report

## Public Rights-of-Way

### (Curb Ramps)

| Intersection ID: 52448 | Main Street: WOODWARD_AV | Cross Street: DOUBLE_OAKS_RD | Location: NE |

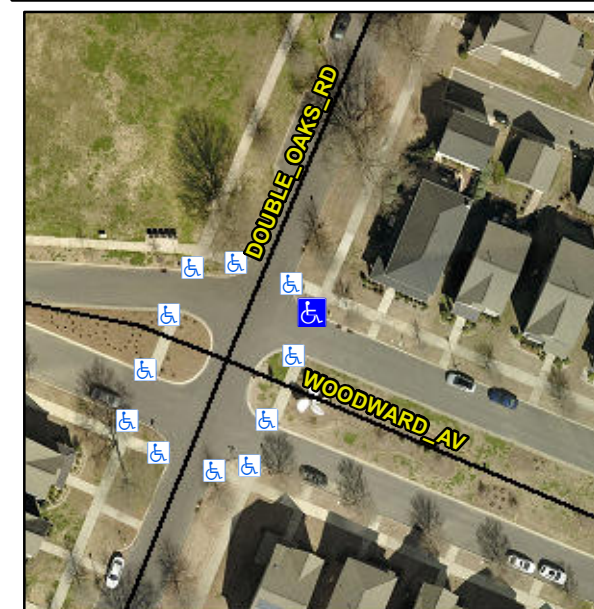
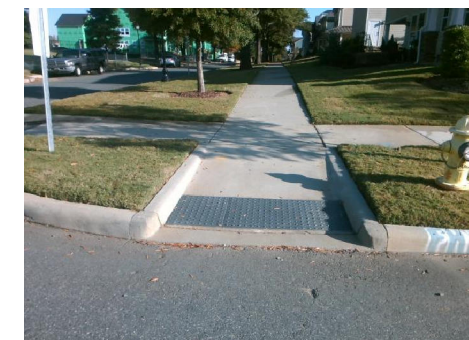
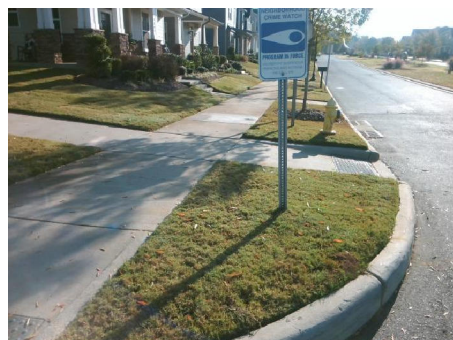
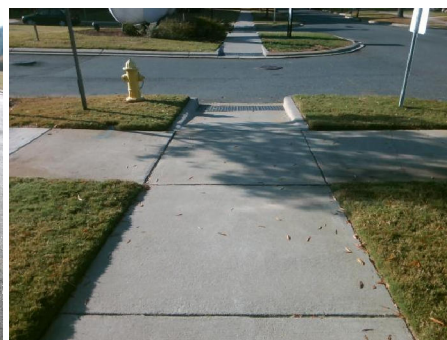
**R304.2.2, R304.5.3**

| Compliance | Description | Data | Compliance | Description | Data |
|---|---|---|---|---|---|
| No | Ramp Slope (%) | 10.5 | N/A | Grade Break XSlope (%) | 0.0 |
| No | Ramp XSlope (%) | 2.2 | | | |

**Remove & Replace Entire Ramp.**
