Access Compliance Report

Public Rights-of-Way (Curb Ramps)

Intersection ID: 10982	Main Street: LANECREST_DR	Cross Street: MENDHAM_DR	Location: NW
ADA ID: AB711DB9E6B3	Ramp Type: Directional1	Initial Pass/Fail: Fail	Overall Compliance: No
Severity Score: 1.25			
Codes/Mitigation Info/Possible Solution		Field Measurements/Component Compliance

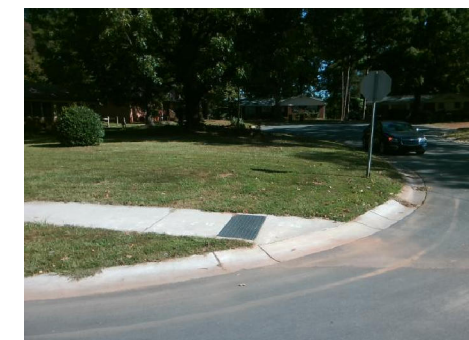
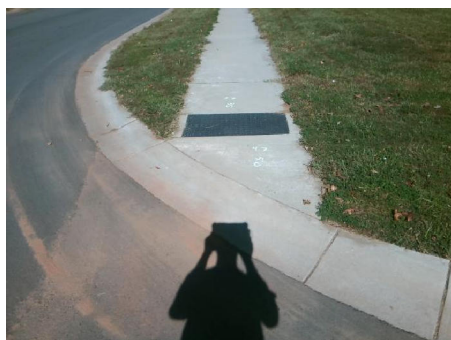
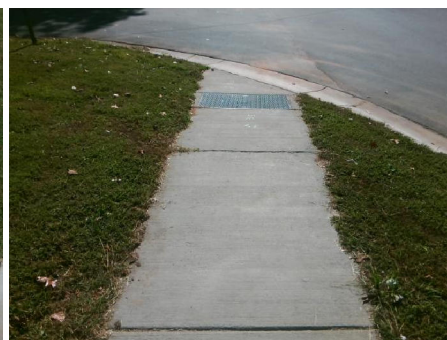
Compliance	Description	Data	Compliance	Description	Data
N/A	Ramp Length (in)	123.0	N/A	Grade Break?	N/A
Yes	Ramp Width (in)	60.0	N/A	Grade Break Slope (%)	0.0
Yes	Ramp Slope (%)	5.2	N/A	Grade Break XSlope (%)	0.0
No	Ramp XSlope (%)	3.7			
N/A	Flare Type LT	N/A	N/A	Flare Type RT	N/A
N/A	Flare Slope LT (%)	N/A	N/A	Flare Slope RT (%)	0.0
N/A	Flare Traversable LT?	N/A	N/A	Flare Traversable RT?	N/A
N/A	Landing Length (in)	0.0	N/A	DWS Provided?	N/A
N/A	Landing Width (in)	0.0	N/A	DWS Contrast?	N/A
N/A	Landing Slope (%)	0.0	N/A	DWS Length (in)	N/A
N/A	Landing X Slope (%)	0.0	N/A	DWS Full Width?	N/A
N/A	Landing Curb? (Y/N)	N/A	N/A	DWS Offset LT (in)	N/A
N/A	Shared Landing?	N/A	N/A	DWS Offset RT (in)	N/A
N/A	Gutter Ponding?	Yes	N/A	Gutter Slope (%)	N/A
N/A	Gutter Lip Ht (in)	0.5	N/A	Gutter X Slope (%)	N/A
N/A	Painted X Walk1?	No		Road Slope (%)	0.8
	X Walk 1 Direction	To SE		Road X Slope (%)	1.6
	X Walk 1 Width (in)	N/A		Clear Space?	N/A

X Walk 1 Slope (%)	0.8	N/A	Clear Space to XWalk (in)	N/A
	X Walk 1 X Slope (%)	1.6	N/A	Storm Grate/Utility Hazard?	N/A
N/A	Ramp inside XWalk1?	N/A		Storm Grate/Utility Type	
N/A	Any Obstructions?	N/A			N/A
	Obstruction Type		Yes	Surface Condition? (G/P)	Good
			N/A	Curb Slope (%)	12.9

Possible Solutions:

Remove & Replace Entire Ramp.

R304.5.3
