# Access Compliance Report

## Public Rights-of-Way

### (Curb Ramps)

Intersection ID: 15094	Main Street: ALBEMARLE_RD	Cross Street: REDDMAN_RD	Location: SW
ADA ID: AB71B4B8F372	Ramp Type: Perp	Initial Pass/Fail: Fail	Overall Compliance: No
		Severity Score: 37.5

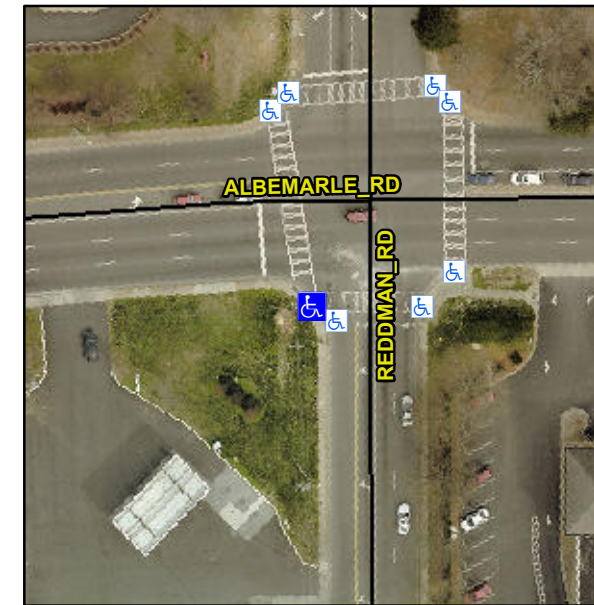
**Not Found, R304.2.2, R304.5.3**

Compliance	Description	Data	Compliance	Description	Data
N/A	Ramp Length (in)	61.0	No	Ramp Slope (%)	11.6
Yes	Ramp Width (in)	48.0	No	Ramp XSlope (%)	9.1
N/A	Flare Type LT	N/A	N/A	Flare Type RT	N/A
N/A	Flare Slope LT (%)	N/A	N/A	Flare Slope RT (%)	N/A
N/A	Flare Traversable LT?	N/A	N/A	Flare Traversable RT?	N/A
N/A	Landing Length (in)	N/A	N/A	DWS Provided?	N/A
N/A	Landing Width (in)	N/A	N/A	DWS Contrast?	N/A
N/A	Landing Slope (%)	N/A	N/A	DWS Length (in)	N/A
N/A	Landing X Slope (%)	N/A	N/A	DWS Full Width?	N/A
N/A	Landing Curb? (Y/N)	N/A	N/A	DWS Offset (in)	N/A
N/A	Shared Landing?	N/A			
N/A	Gutter Ponding?	N/A	N/A	Gutter Slope (%)	N/A
N/A	Gutter Lip Ht (in)	N/A	N/A	Gutter X Slope (%)	N/A
N/A	Painted X Walk1?	Yes	N/A	Painted X Walk2?	N/A
	X Walk 1 Direction	To N		X Walk 2 Direction	N/A
N/A	X Walk 1 Width (in)	116.0	N/A	X Walk 2 Width (in)	N/A
	X Walk 1 Slope (%)	7.2		X Walk 2 Slope (%)	N/A
	X Walk 1 X Slope (%)	3.3		X Walk 2 X Slope (%)	N/A

N/A	Ramp inside XWalk1?	Yes	N/A	Ramp inside XWalk2?	N/A
	Road Slope (%)	N/A	N/A	Clear Space?	N/A
	Road X Slope (%)	N/A	N/A	Clear Space to XWalk (in)	N/A
N/A	Any Obstructions?	N/A	N/A	Storm Grate/Utility Hazard?	N/A
	Obstruction Type			Storm Grate/Utility Type	
		N/A			N/A
		Yes		Surface Condition? (G/P)	Good

**Remove & Replace Entire Ramp.**

Total Cost: \$ 1850.00
