# Access Compliance Report

## Public Rights-of-Way

### (Curb Ramps)

Intersection ID: 10014556	Main Street: HARRIS_CENTER_DR	Cross Street: N/A	Location: S
ADA ID: AB74AAC5E6C0	Ramp Type: BlendTrans1	Initial Pass/Fail: Fail	Overall Compliance: No
Severity Score: 8.75			
Codes/Mitigation Info/Possible Solution		Field Measurements/Component Compliance

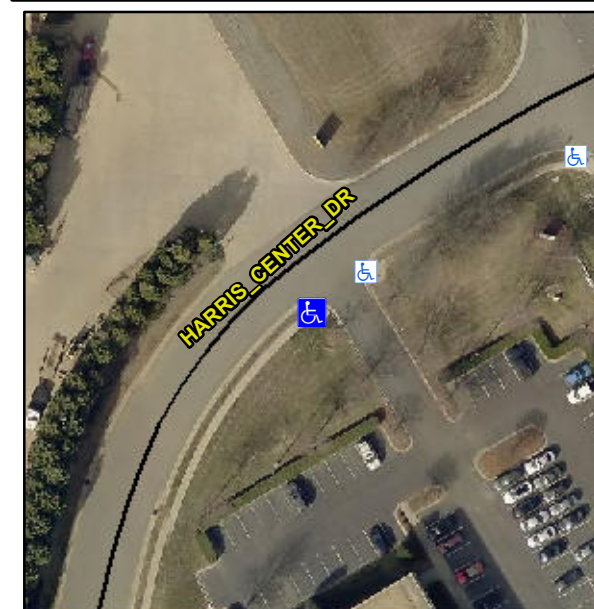
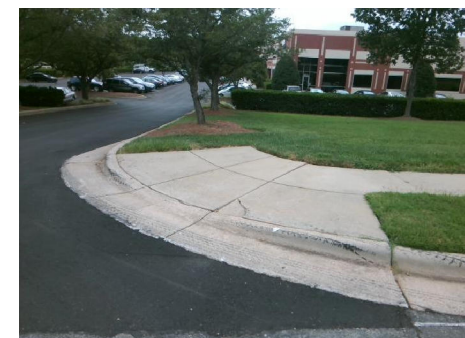
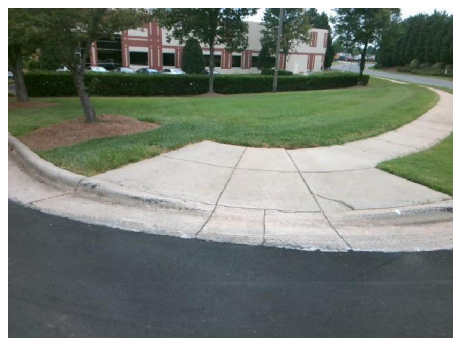
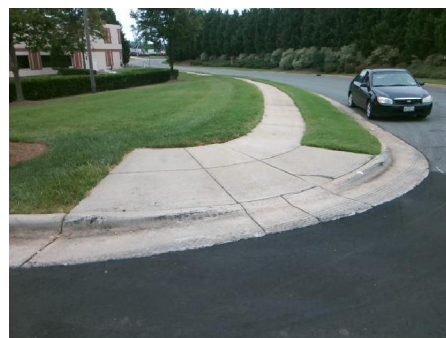
**NO LT SW**

**Not Found, R304.5.1**

Compliance	Description	Data	Compliance	Description	Data
N/A	Ramp Length (in)	50.0	Yes	BlendTrans Slope (%)	1.9
No	Ramp Width (in)	36.0	Yes	BlendTrans XSlope (%)	1.9
N/A	Flare Type LT	N/A	N/A	Flare Type RT	N/A
N/A	Flare Slope LT (%)	N/A	N/A	Flare Slope RT (%)	N/A
N/A	Flare Traversable LT?	N/A	N/A	Flare Traversable RT?	N/A
N/A	Landing Length (in)	N/A	N/A	DWS Provided?	N/A
N/A	Landing Width (in)	N/A	N/A	DWS Contrast?	N/A
N/A	Landing Slope (%)	N/A	N/A	DWS Length (in)	N/A
N/A	Landing X Slope (%)	N/A	N/A	DWS Full Width?	N/A
N/A	Landing Curb? (Y/N)	N/A	N/A	DWS Offset (in)	N/A
N/A	Shared Landing?	N/A			
N/A	Gutter Ponding?	N/A	N/A	Gutter Slope (%)	N/A
N/A	Gutter Lip Ht (in)	N/A	N/A	Gutter X Slope (%)	N/A
N/A	Painted X Walk1?	No	N/A	Painted X Walk2?	N/A
	X Walk 1 Direction	To E		X Walk 2 Direction	N/A
	X Walk 1 Width (in)	N/A		X Walk 2 Width (in)	N/A
	X Walk 1 Slope (%)	0.9		X Walk 2 Slope (%)	N/A
	X Walk 1 X Slope (%)	3.9		X Walk 2 X Slope (%)	N/A

N/A	Ramp inside XWalk1?	N/A	N/A	Ramp inside XWalk2?	N/A
	Road Slope (%)	3.9		Clear Space?	N/A
	Road X Slope (%)	0.9	N/A	Clear Space to XWalk (in)	N/A
N/A	Any Obstructions?	N/A	N/A	Storm Grate/Utility Hazard?	N/A
	Obstruction Type			Storm Grate/Utility Type	
		N/A			N/A
			Yes	Surface Condition? (G/P)	Good
			No	Curb Slope (%)	10.7

**Remove & Replace Curb Ramp With Two New Directional Ramps or Equivalent.**
