Access Compliance Report

Public Rights-of-Way (Curb Ramps)

Intersection ID: 44162	Main Street: MEADOW_KNOLL_DR	Cross Street: PASSION_FLOWER_WY	Location: SW
ADA ID: AB7EB3A031A9	Ramp Type: PerpDiag	Initial Pass/Fail: Fail	Overall Compliance: No
Severity Score: 21.25			
Codes/Mitigation Info/Possible Solution		Field Measurements/Component Compliance

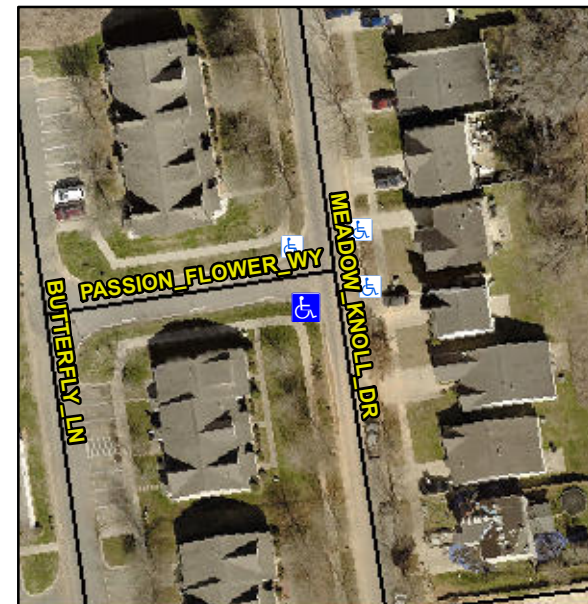
Not Found, R304.5.1, R304.5.3

Compliance	Description	Data	Compliance	Description	Data
N/A	Ramp Length (in)	86.0	Yes	Ramp Slope (%)	6.3
No	Ramp Width (in)	46.5	No	Ramp XSlope (%)	5.3
N/A	Flare Type LT	N/A	N/A	Flare Type RT	N/A
N/A	Flare Slope LT (%)	N/A	N/A	Flare Slope RT (%)	N/A
N/A	Flare Traversable LT?	N/A	N/A	Flare Traversable RT?	N/A
N/A	Landing Length (in)	N/A	N/A	DWS Provided?	N/A
N/A	Landing Width (in)	N/A	N/A	DWS Contrast?	N/A
N/A	Landing Slope (%)	N/A	N/A	DWS Length (in)	N/A
N/A	Landing X Slope (%)	N/A	N/A	DWS Full Width?	N/A
N/A	Landing Curb? (Y/N)	N/A	N/A	DWS Offset (in)	N/A
N/A	Shared Landing?	N/A			
N/A	Gutter Ponding?	N/A	N/A	Gutter Slope (%)	N/A
N/A	Gutter Lip Ht (in)	N/A	N/A	Gutter X Slope (%)	N/A
N/A	Painted X Walk1?	No	N/A	Painted X Walk2?	No
	X Walk 1 Direction	To E		X Walk 2 Direction	To N
N/A	X Walk 1 Width (in)	N/A	N/A	X Walk 2 Width (in)	N/A
	X Walk 1 Slope (%)	1.2		X Walk 2 Slope (%)	3.0
	X Walk 1 X Slope (%)	4.2		X Walk 2 X Slope (%)	4.5

N/A	Ramp inside XWalk1?	N/A	N/A	Ramp inside XWalk2?	N/A
	Road Slope (%)	4.9	N/A	Clear Space?	N/A
	Road X Slope (%)	1.2	N/A	Clear Space to XWalk (in)	N/A
N/A	Any Obstructions?	N/A	N/A	Storm Grate/Utility Hazard?	N/A
	Obstruction Type			Storm Grate/Utility Type	
		N/A			N/A
		Yes		Surface Condition? (G/P)	Good

Remove & Replace Curb Ramp With Two New Directional Ramps or Equivalent.
